Roads & Bridges Committee
NOTICE OF MEETING

Re: Drainage Issues

Re: Porter Bridge Inspection

Re: Structure Number: 049-3076
Village of Barrington Hills
WJE No. 2017.4394

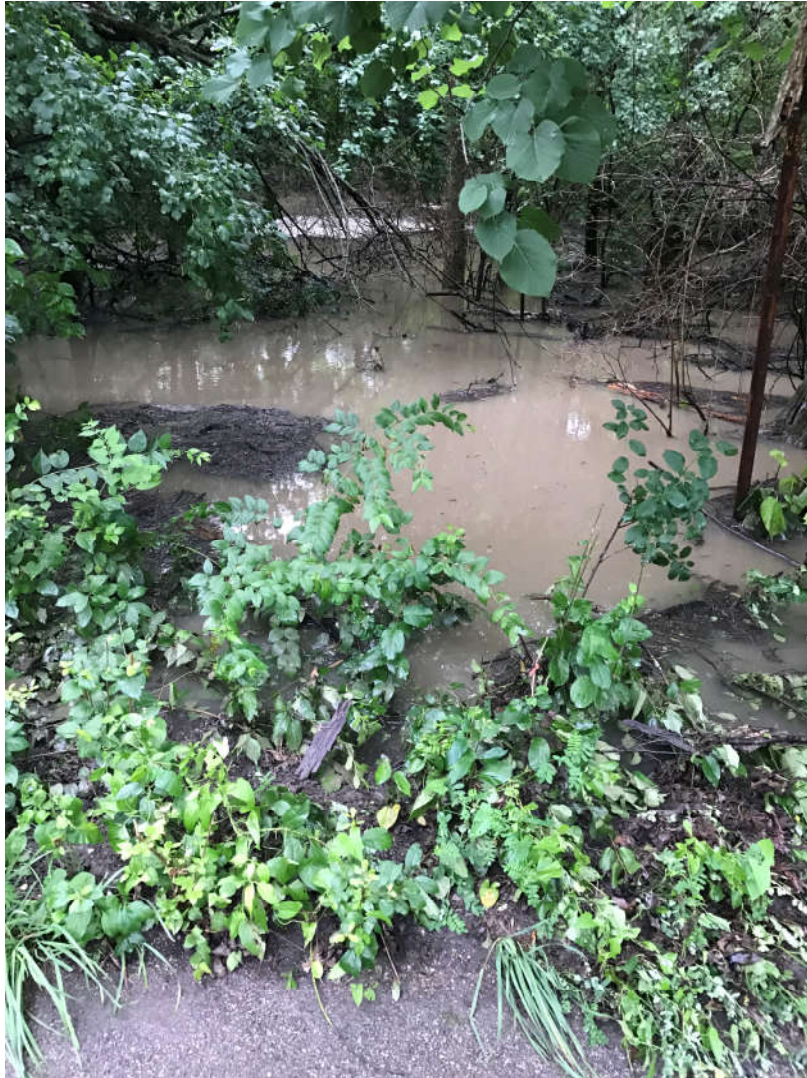
Hills N Dales Culvert

Hills N Dales Road was overtopped just east of Honeycutt Road during the storm event. As you can see, water is nearly extended on to the pavement. There is a concrete culvert in the area which carries storm water that flows from southeast to northwest across Hills N Dales Road. The upstream end of the culvert connects to a manhole structure, covered by a flat metal grate. The grate often is clogged with debris and leaves. Part of the 2017 Road Program includes replacing this structure with a modified inlet box that would be less prone to becoming clogged and still handle the capacity of water in the area.

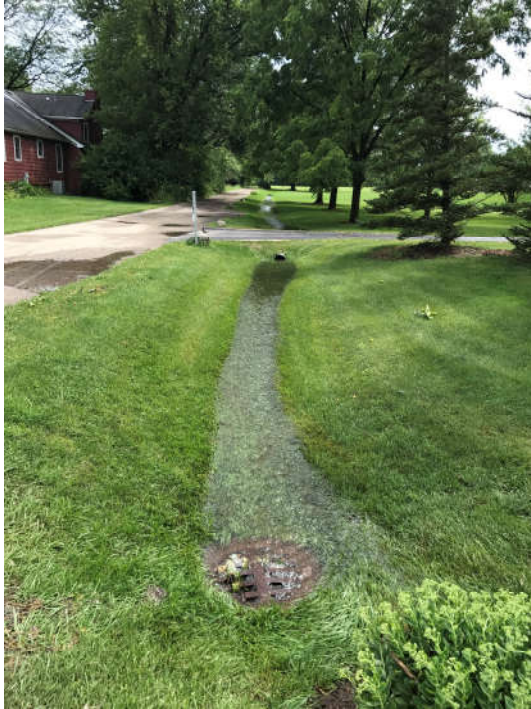
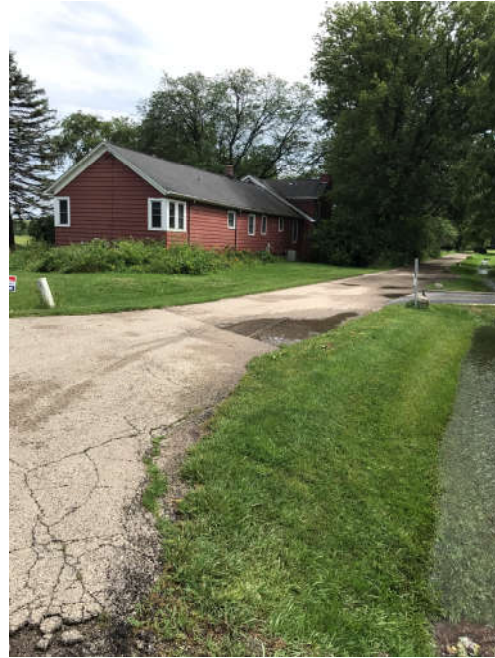
The resident at 573 W. Cuba Road notified Village staff that rainfall event had flooded part of his basement. Upon arrival and property inspection, no abnormal ponding of water could be identified around the property. Ditch culverts and storm sewer seemed to be working adequately in the adjacent property.

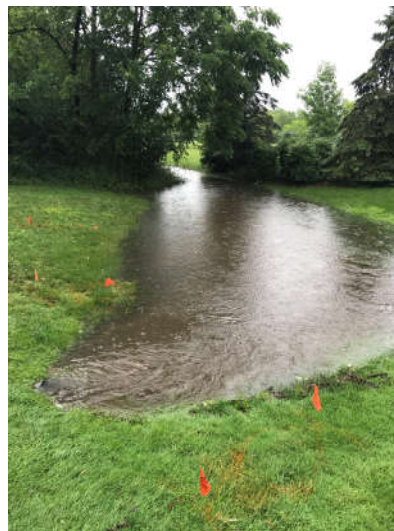
Old Hart Road Drainage

As noted in the spring drainage review, the roadway culvert at 41 Old Hart Road cannot handle the capacity of a significant rainfall. The 2017 Road program proposes to install a new 24' RCP culvert roughly 200' north to allow intercept of part of this tributary, along with replacing the culvert shown in the picture below.

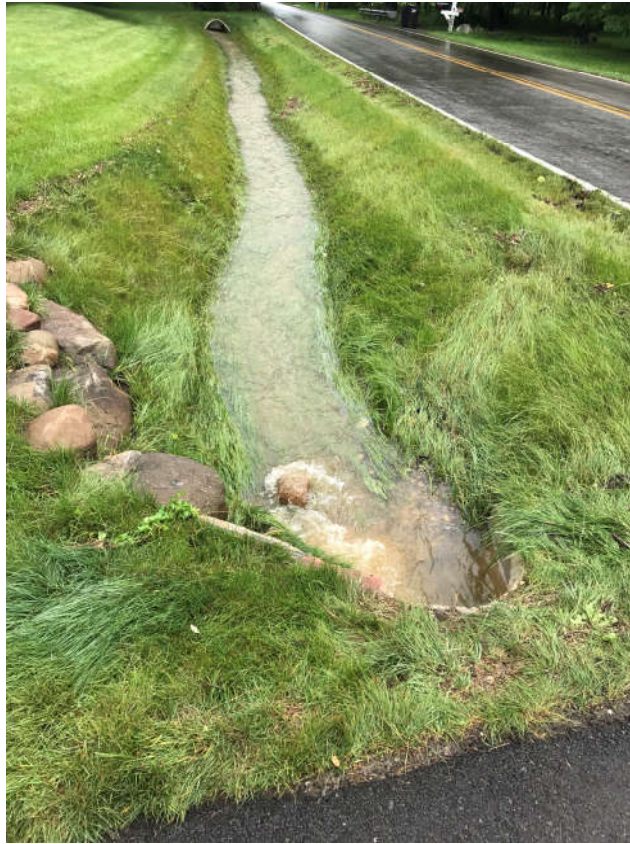
River Road Drainage

Pictured below is the roadway ditch in front of 10123 River Road. The resident notified Village staff that a tree had overtopped during the rain event and caused clogging of the culvert which resulted in flooding of part of his property. Upon arrival, the tree had been removed. He mentioned that Lorig Construction did a good job with installing the culvert; however, the culvert was not installed with flared end section grates when they were put in last year. We will notify Lorig to install the required grate.

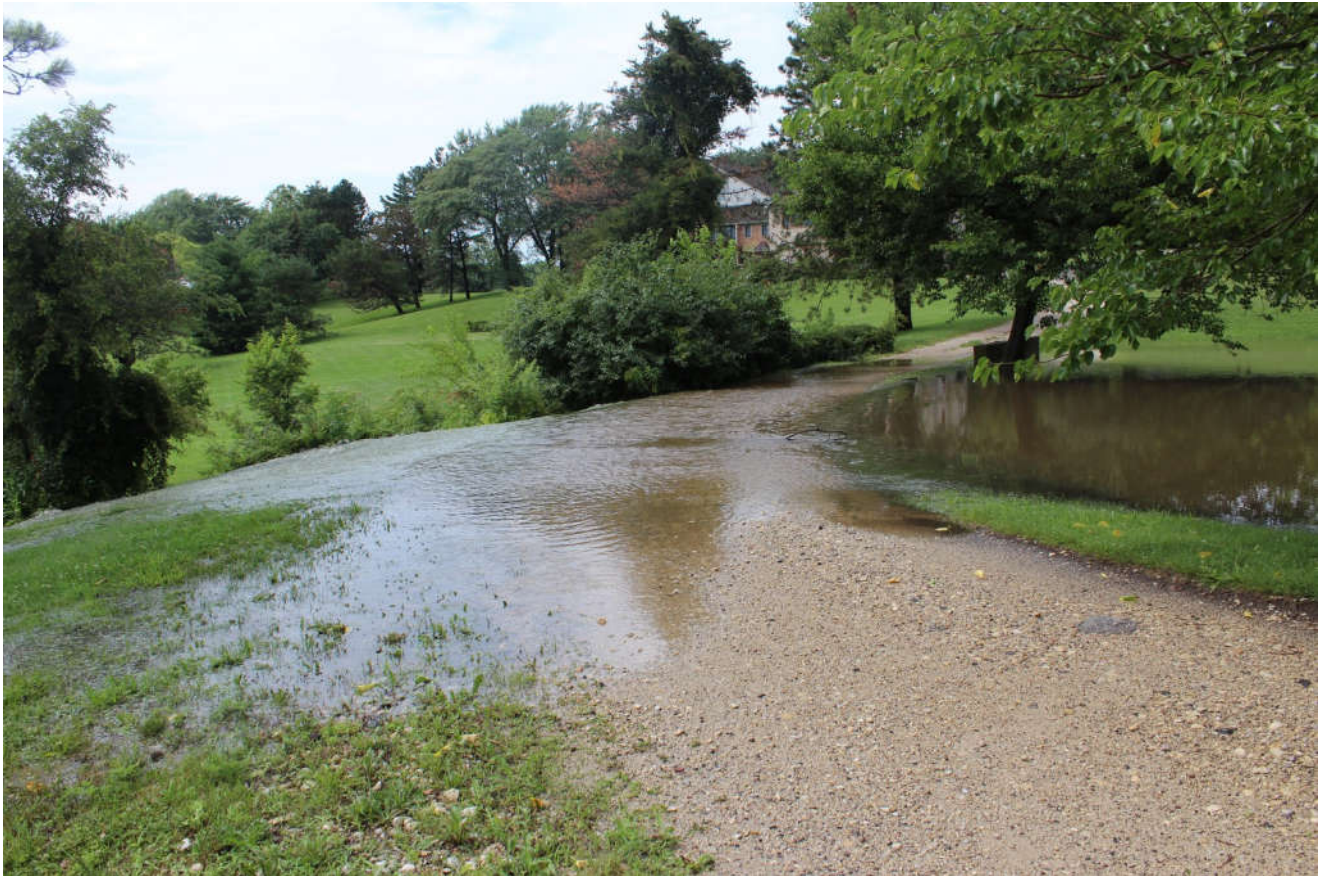
Dundee Lane Drainage

Dundee Lane overtopped just north of Sara Lane; this location also overtopped during a March rainfall event. At this location, a 30" CMP crosses Dundee Lane, draining the Motorwerks/Southgate area in the Village of Barrington as well as areas in Barrington Hills, draining into a private pond on the west side of Dundee Lane. There is an outlet structure on the west side of the pond at the residential driveway, which was overtopping as shown below.

There is significant vertical relief on the west side of the driveway. If the Village were to work with the property owner to lower the outlet structure for the pond, Dundee Lane would be less prone to overtopping in this area; the work could also be designed to reduce the occurrence of driveway overtopping.

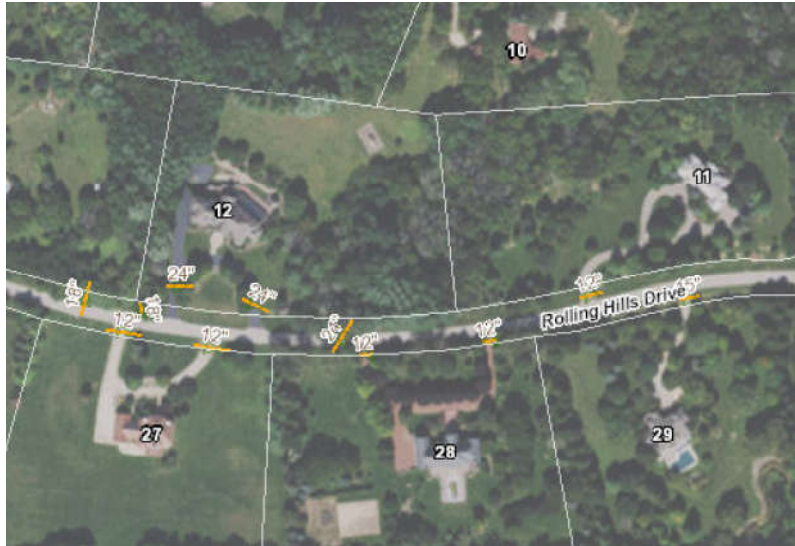
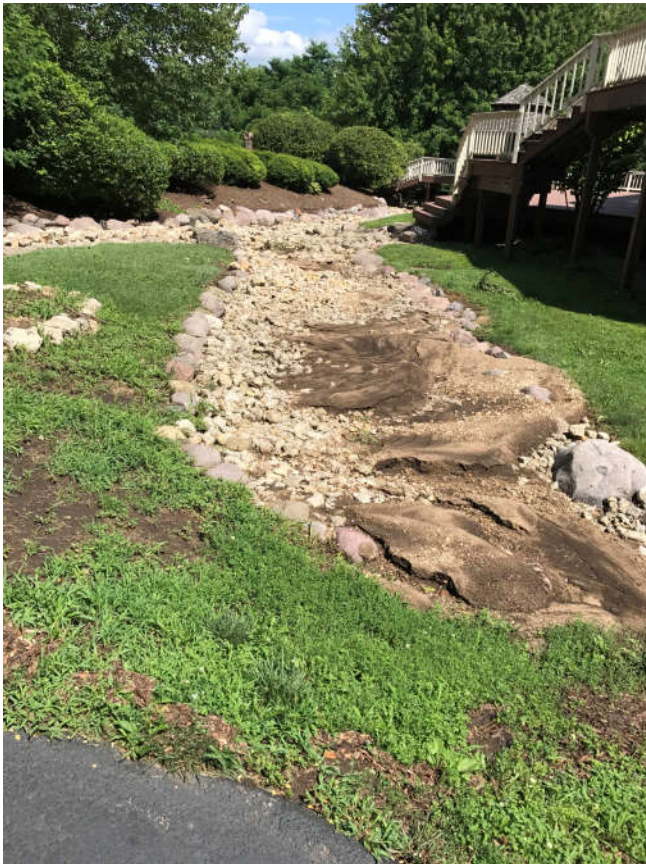
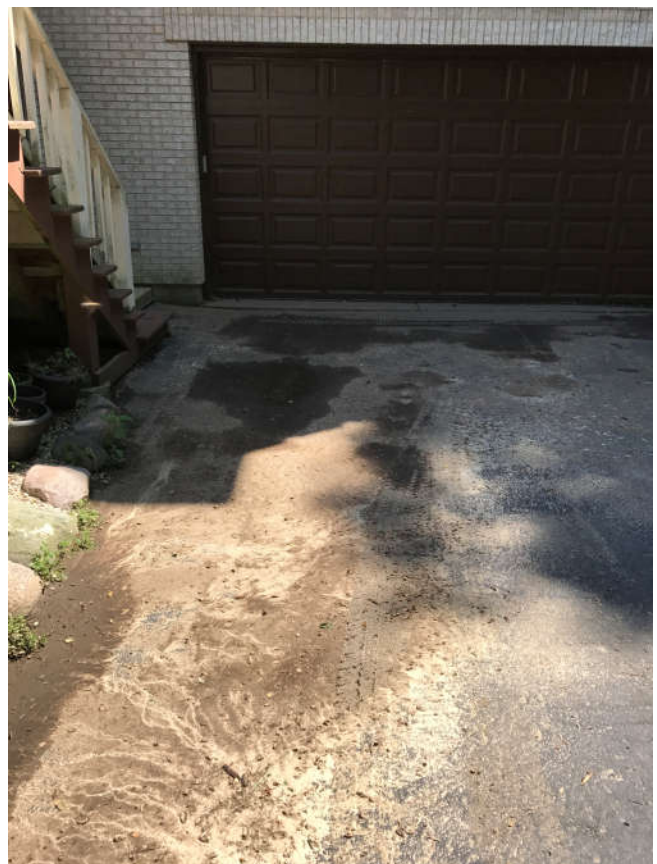
12 Rolling Hills Drive

The resident at 12 Rolling Hills contacted the Village with concerns regarding erosion of an existing swale and residential flooding. Current, runoff flows from the northwest property through an existing channel that is lined and covered with stone. The recent rainfall event eroded away portions of the ditch and moved the boulders before overtopping and flooding parts of the residents garage.

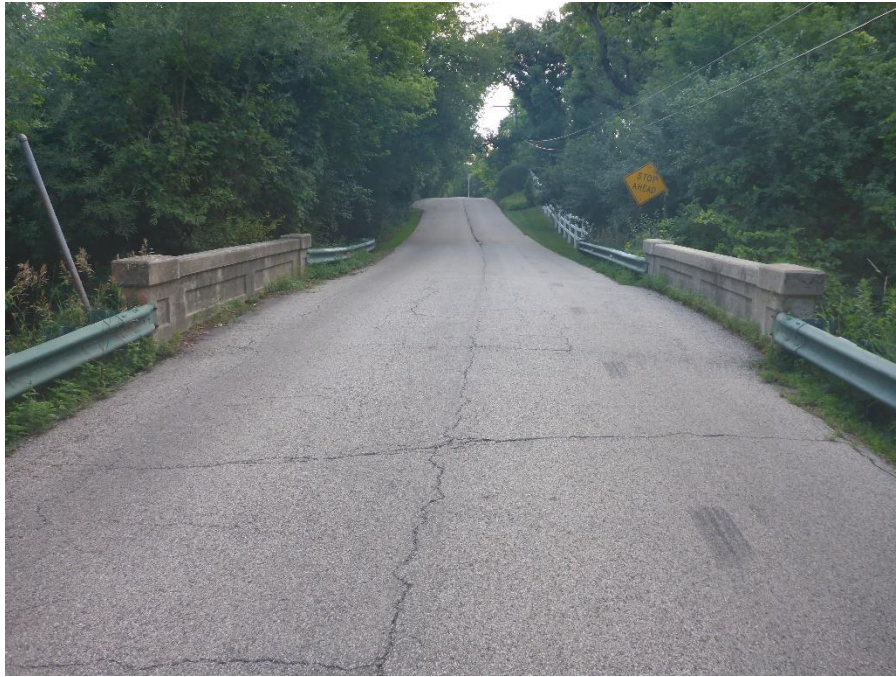
Figure 1. Porter Bridge looking west.

There were no visible signs of distress to the structure that could be attributed to the recent and continued high water flow and decreased freeboard. Photos from the inspection performed in June 2016 were

compared to current conditions and no appreciable differences in the performance of the structure were noted. These comparisons included conditions that would indicate settlement of bridge components, nearby soil, and/or the approach pavements. Additionally, there were no large debris noticed in the water flow while on site and no debris restricting the opening beneath the bridge.

At the time of the inspection, the bridge had no visible signs of scour-related damage requiring immediate action. However, once the flow has decreased to a safe level for entry into the water, it is recommended that a scour inspection be performed to probe the channel bottom for scour along the east and west abutments and wingwalls. During this inspection, channel cross-sections along the upstream and downstream fascias should be documented.

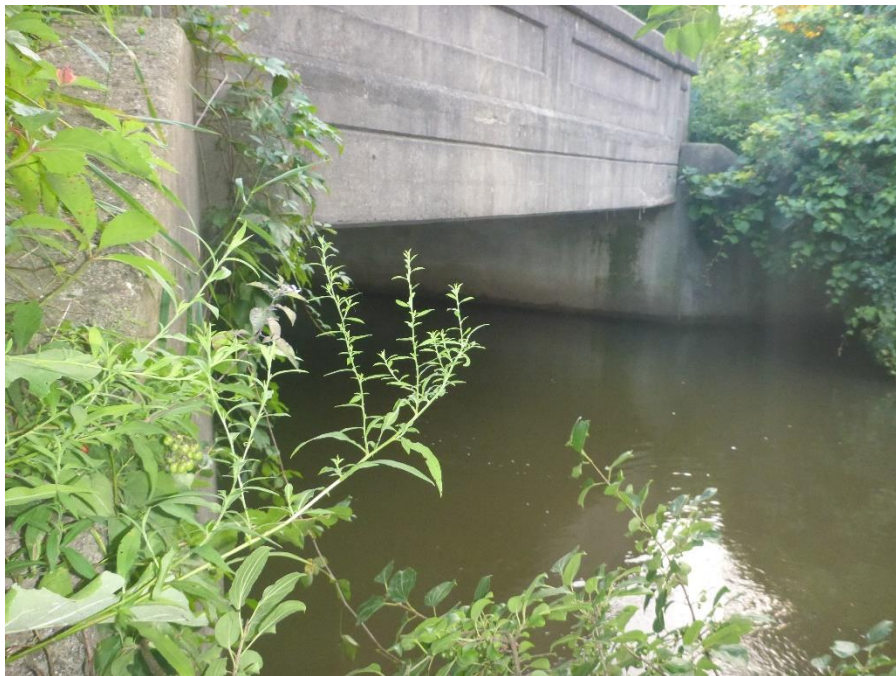
Figure 2. Bridge elevation looking southwest.

At the time of inspection, the waterway had a freeboard dimension of 4 ft-1 in. Dampness on the wingwalls and abutments indicated that the water was recently higher by approximately 4 in., if not more. For comparison, the freeboard during the 2016 routine inspection was approximately 6 ft-10 in. The flow rate of the top surface was approximated as 2 ft/sec and the water was not entered. Therefore, the bridge was accessed by the roadway, wingwalls, and available creek banks for this inspection.
