A RESOLUTION AUTHORIZING THE EXECUTION OF AN AGREEMENT WITH KINGS CONTRACTING, INC. FOR THE REPAIR OF THE ROOF OF VILLAGE PROPERTY AT 120 ALGONQUIN ROAD

To: Trustee Zubak
From: Robert Kosin
cc: Board of Trustees, Village President
Date: September 22, 2017
Re: Fire Station Roof Repair

**RE: Fire Station #2
Barrington Hills, IL**

PROJECT: Village of Barrington Hills Fire Station #2			JOB NO.: 14001
ROOF AREA: North Roof	ROOF AGE: 20 years	BLDG TYPE: Masonry	ROOF SLOPE: 5:12
EVALUATION BY: Robert Heideman and William Richardson on April 11, 2014

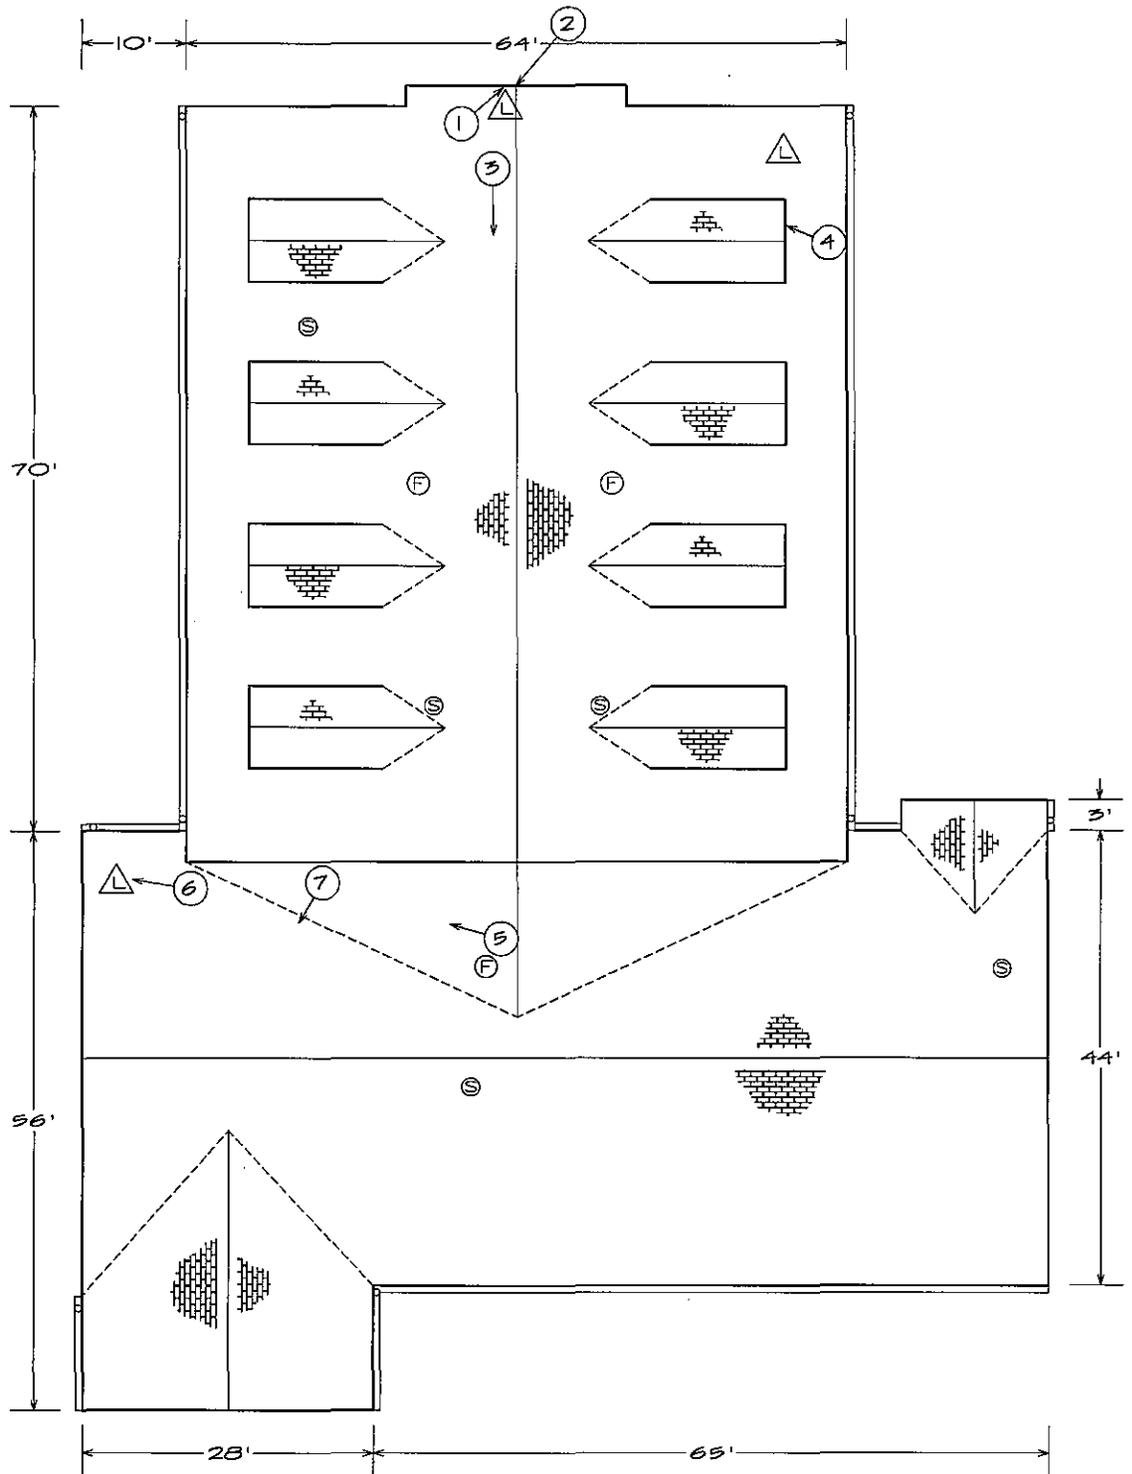
RS - 1

It was reported that water infiltration occurred at the north end of the apparatus room in February 2011. Evidence of this leak is visible at a drywall joint in the ceiling. The location of the damaged drywall coincides with the location of a functioning gable vent in the attic above. A second leak was reported in the apparatus room due east from the above leak. Its size was much smaller and is located in the vicinity of a dormer. The specific circumstances about the occurrence of this leak were not known. A third leak was reported in an electronics room under the newly installed shingles. The leak is located near the northwest corner of the area.

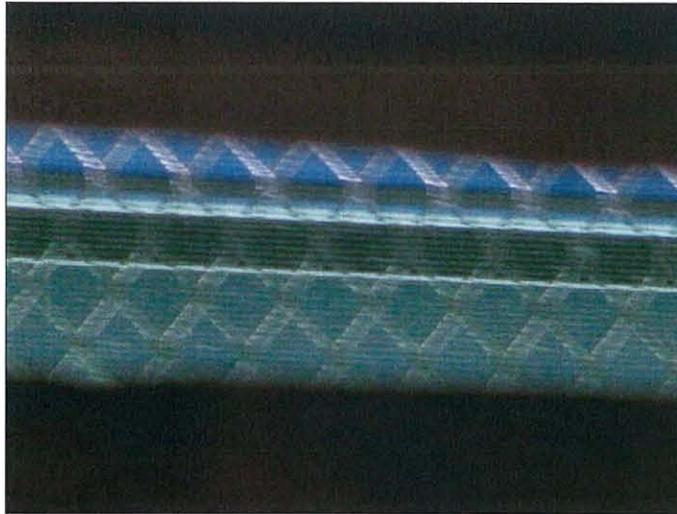
The damage at the north perimeter of the apparatus room is located in the vicinity of a gable vent as mentioned above. The damage was noticed shortly after the blizzard that the area experienced in February 2011. The blizzard brought with it near record-breaking snow accumulations and extremely high winds. Photo #1 shows the gable vent from the interior. To keep pests out, approximately one inch screening was used over the gable opening. An inspection of the roofing at this area showed no defects. It is my opinion that the large quantities of wind driven snow experienced during that storm created the variables necessary for snow to enter the attic through the gable vent and accumulate in the attic. To prevent future occurrences, the Village could consider installing screen with smaller openings that in effect will filter the snow that tries to enter into the attic through the gable. This will have little effect on the function of the gable vent.

1. GABLE VENT (TYPICAL)

1. Consider installing smaller screening on gable vent. (Photo #1)
2. Seal open caulking. (Photo #4)
3. Re-secure heat cable mounts. (Photo #7)

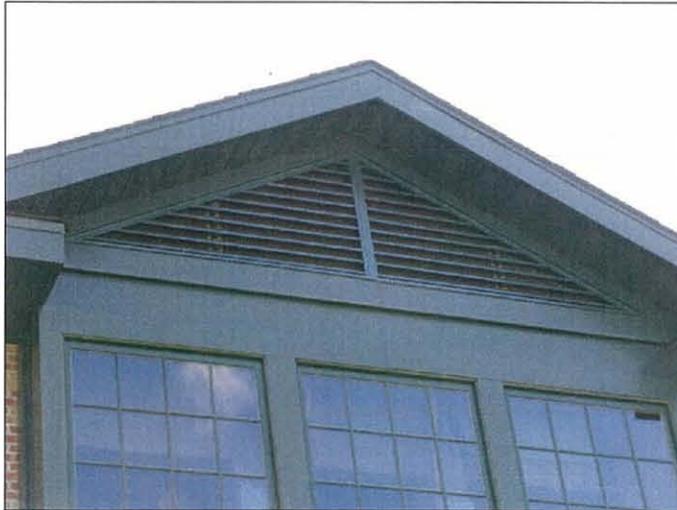
2. GABLE VENT (TYPICAL)

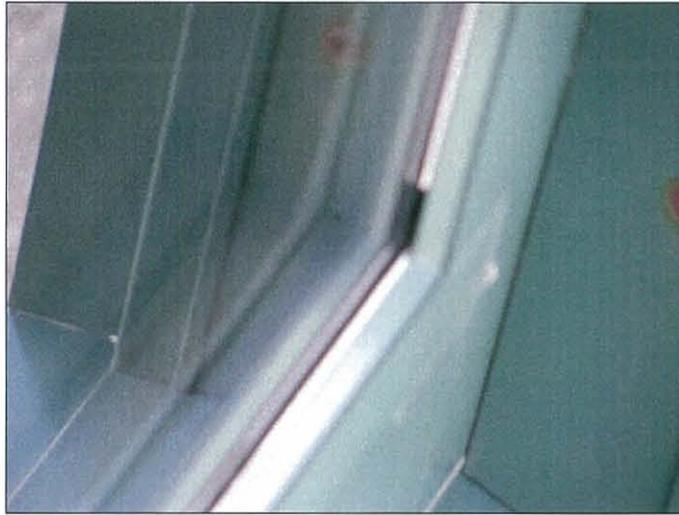
The second leak in the apparatus room is located in the vicinity of the northeast dormer. It is possible that this is also related to the snow accumulation that occurred during the blizzard. There were minor sealant defects found on the window that will require repair. If the leak occurs again in the future, the conditions necessary to make this leak occur should be noted to ensure that an effective repair is made.

4. OPEN SEALANT

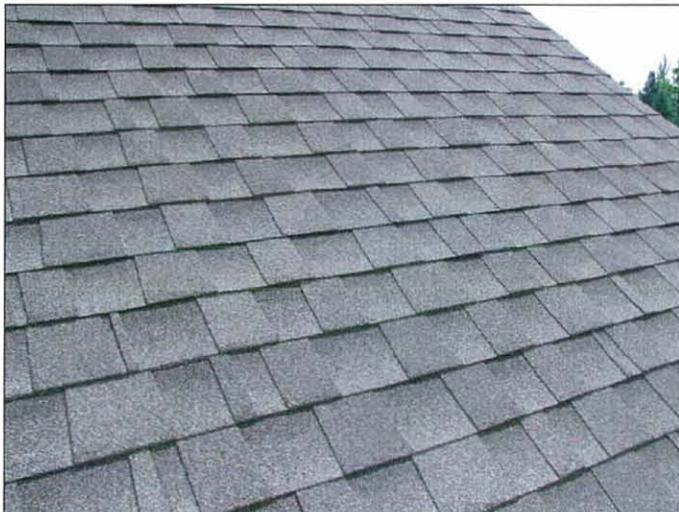
The final leak in the electrical room is located in the field of the roof area, approximately five feet south and east of the northwest corner. The shingles appeared to be installed in this area and showed no defects. Recent repairs were made to the corner of the adjacent structure that could allow water into the building. This leak should be monitored, and if still active, the conditions necessary to cause the leak to occur should be noted. A water test may be necessary to pinpoint the exact point of entry if this leak continues to occur.

6. OVERVIEW OF LEAK AREA

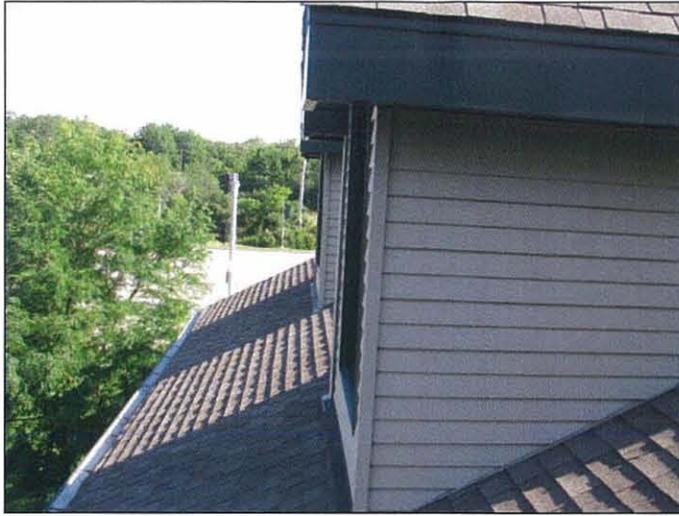
The leaks were reported to occur near the west end of the Apparatus Room. The two leak locations coincide with the location of the dormers that are visible from the outside of the building. Leaks were reported to have never appeared at these locations prior to the storm. It is not known if these leaks have occurred since the original storm.

1. OVERVIEW-DORMER

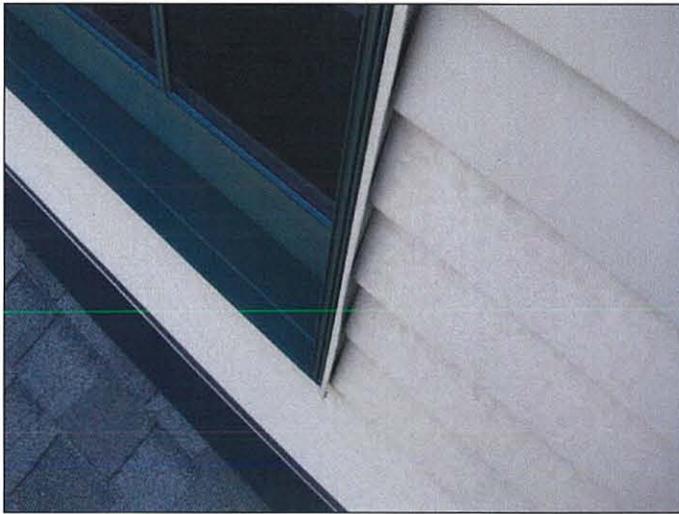
During the investigation of the roofing in the leak areas, no significant defects were found. The investigation moved to the windows and siding on the dormer. The windows were properly sealed and showed no defects. The siding was detailed correctly with one exception. When investigating the flashings and terminations, there was no felt or polyethylene underlayment visible. This underlayment serves multiple purposes, one of them being waterproofing. Siding is water shedding, not waterproof and extreme conditions can allow moisture to migrate behind the siding. Underlayment can be looked at as a final line of defense should moisture penetrate behind the siding. It is my opinion that the extreme weather conditions during this storm created a situation where water was blown behind the siding and ran down the unprotected walls, where it eventually entered into the building.

2. WINDOW DETAIL (TYPICAL)

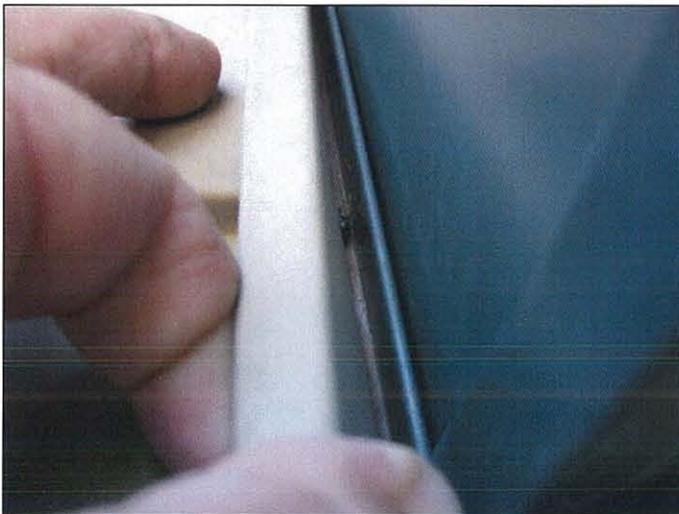
3. MISSING UNDERLAYMENT

should a breach occur. Our recommendation is to remove the siding currently in place on the dormers to allow for the installation of an underlayment membrane. Since the siding will likely incur damage during removal, new siding should be installed. Installing the underlayment will prevent moisture that gets behind the siding during extreme weather from entering the building.

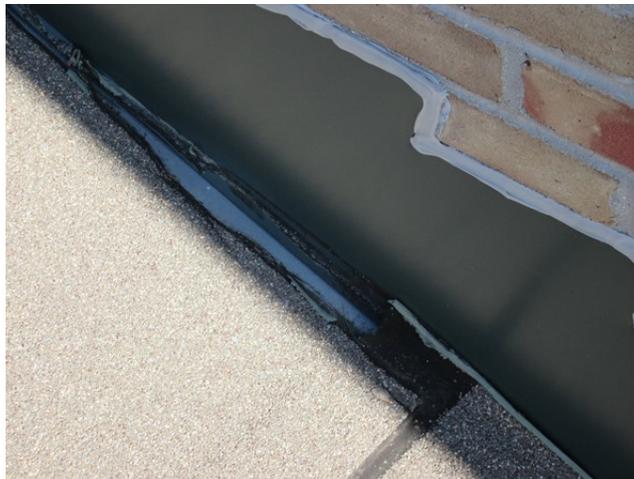
Low slope valley on east side has open seams at wall and ridge, heat cables detached

2. OPEN FLASHING

1. Repair open seams on low slope valley east side (Photos #2 & 4)
2. Remove backed out fastener, install new fastener (Photo #3)

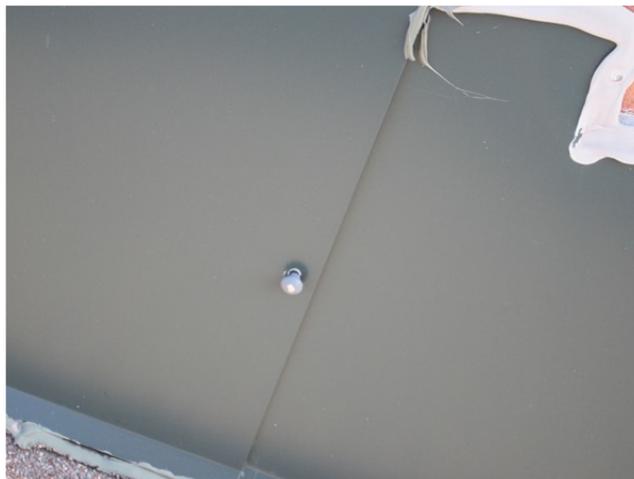
3. BACKED OUT FASTENER

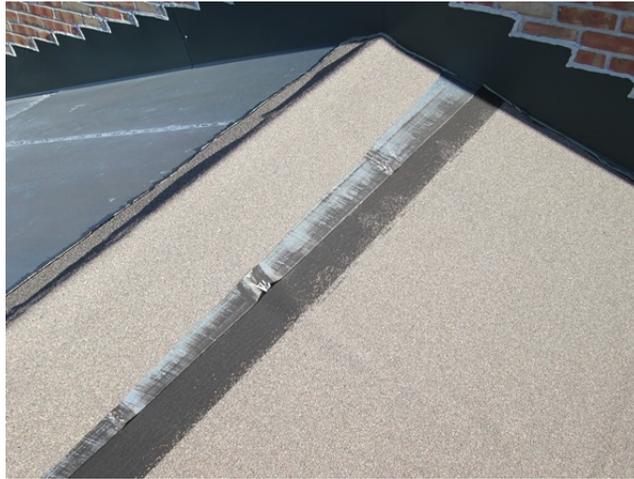
4. OPEN LAP SEAM

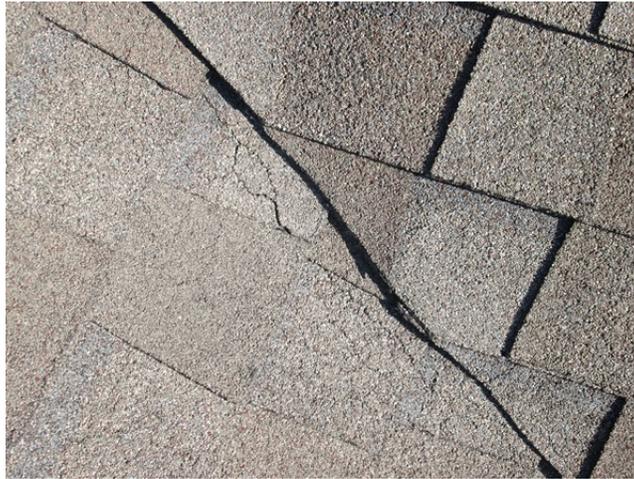
Shingles: Architectural Color: Tan / brown Attachment: Hand nailed Underlayment: Felt with ice barrier product	Lifted plywood, split shingles, backed out fasteners, damaged shingles	MATERIALS: Poor WORKMANSHIP: Marginal CONSTRUCTION: Acceptable GRANULE ADHESION: Marginal
Ridges: Shingled, not vented	Deteriorated ridge cap	MATERIALS: Marginal WORKMANSHIP: Marginal CONSTRUCTION: Acceptable
Valleys: Closed cut	Cracked shingles	MATERIALS: Poor WORKMANSHIP: Marginal CONSTRUCTION: Acceptable
Flashings: Baby tins at dormers / walls / chimney		MATERIALS: Marginal WORKMANSHIP: CONSTRUCTION: Acceptable
Counterflashings:		MATERIALS: WORKMANSHIP: CONSTRUCTION: Acceptable
Drip edge: Face fastened gutter apron shingle overhang 1"		MATERIALS: Marginal WORKMANSHIP: Marginal CONSTRUCTION: Acceptable
Rake edge: Shingle overhang 1"		MATERIALS: Marginal WORKMANSHIP: Marginal CONSTRUCTION: Acceptable
Venting: Gable vents		MATERIALS: Marginal WORKMANSHIP: Marginal CONSTRUCTION: Acceptable

7. CRACKED SHINGLES IN VALLEY

1. Replace split shingles (Photos #7 & 9)
2. Replace deteriorated ridge caps (Photo #8)
3. Re-nail fastener, seal shingle (Photo #10)
4. Remove shingles, re-nail plywood, install new shingles (Photo #12)

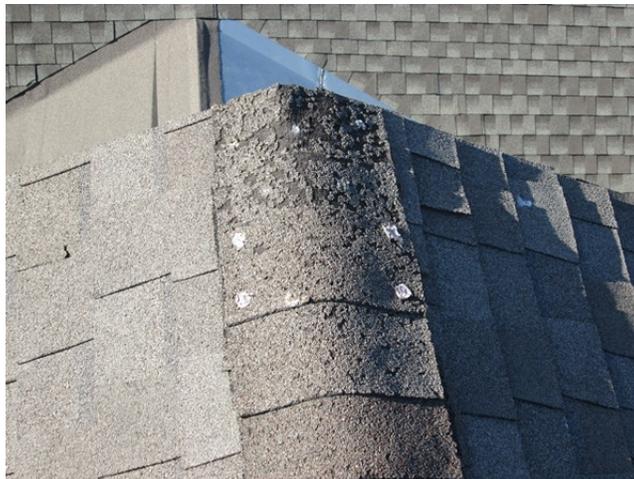
8. DETERIORATED RIDGE CAPS (TYPICAL)

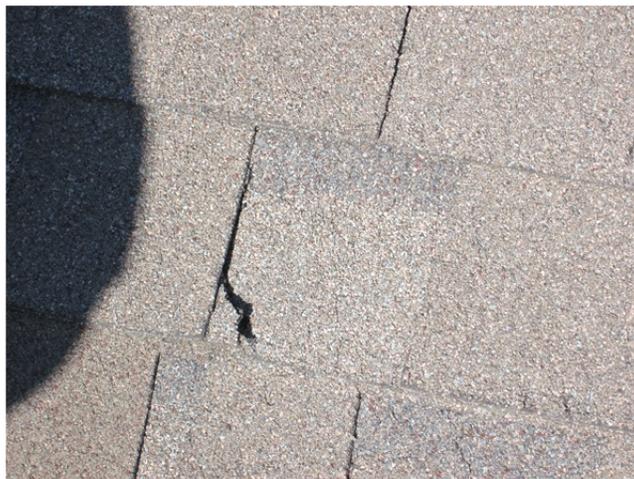
9. CRACKED SHINGLES

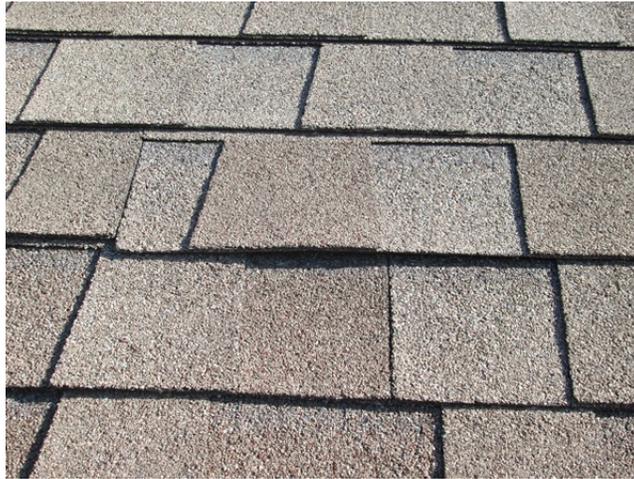
10. BACKED OUT FASTENER

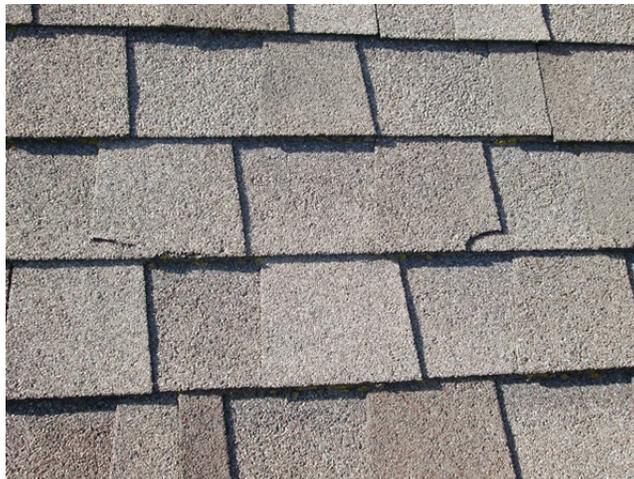
11. DAMAGED SHINGLES

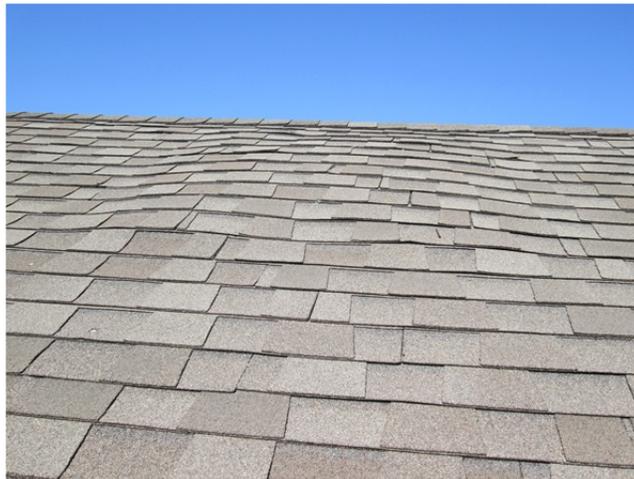
12. LIFTED PLYWOOD

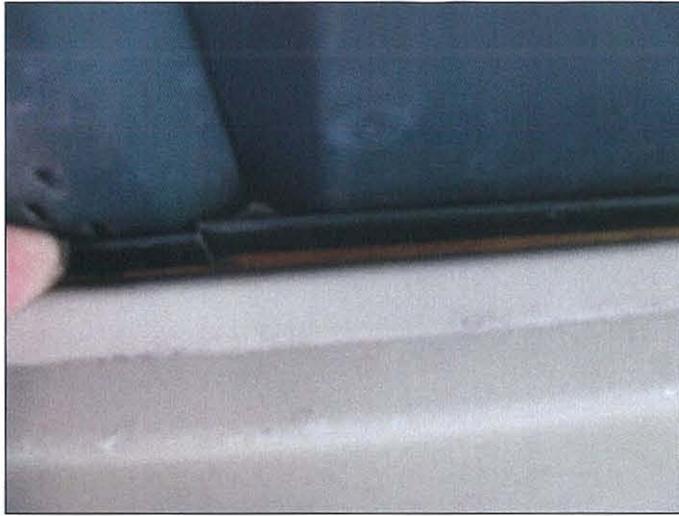
4. MISSING UNDERLAYMENT

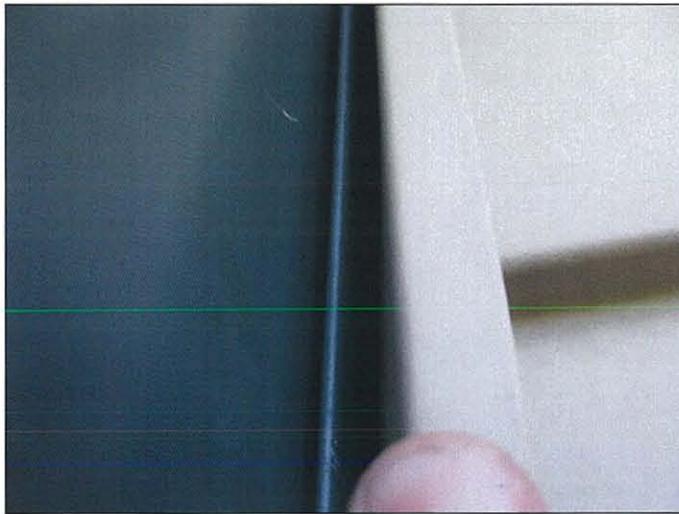
5. MISSING UNDERLAYMENT

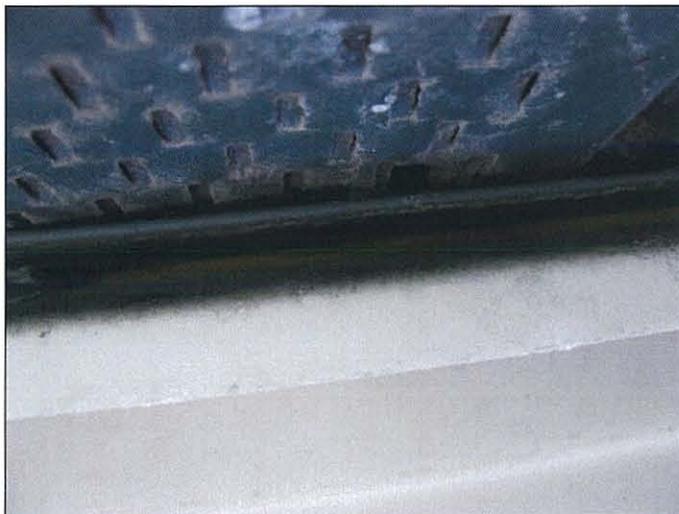
6. MISSING UNDERLAYMENT
