## MEMORANDUM

To: Robert Kosin, VBH Director of Administration  
Brian Cecola, VBH Chairman Roads & Bridges

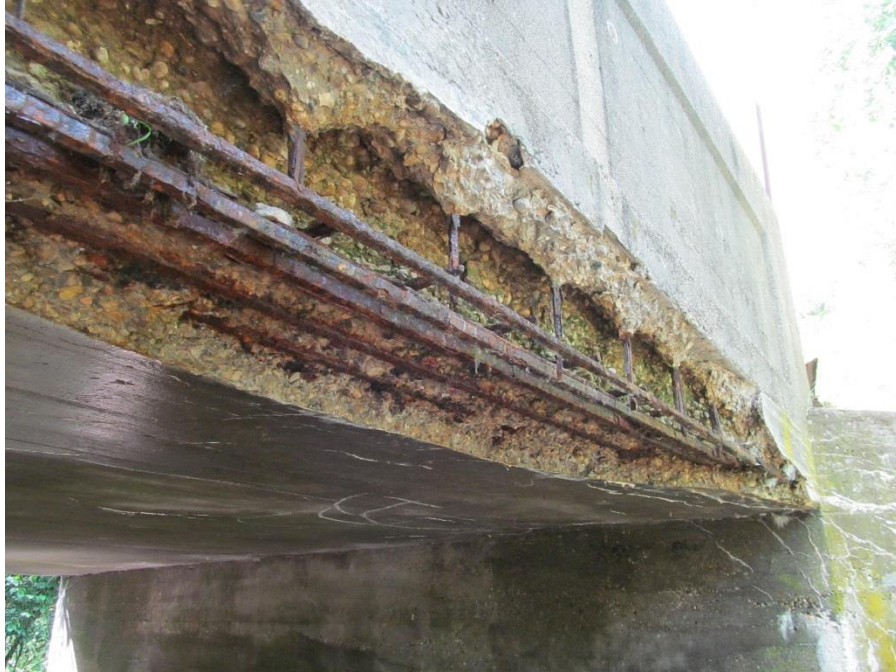
*Figure 3. Spalled concrete and exposed reinforcing bars along east edge of deck soffit.*

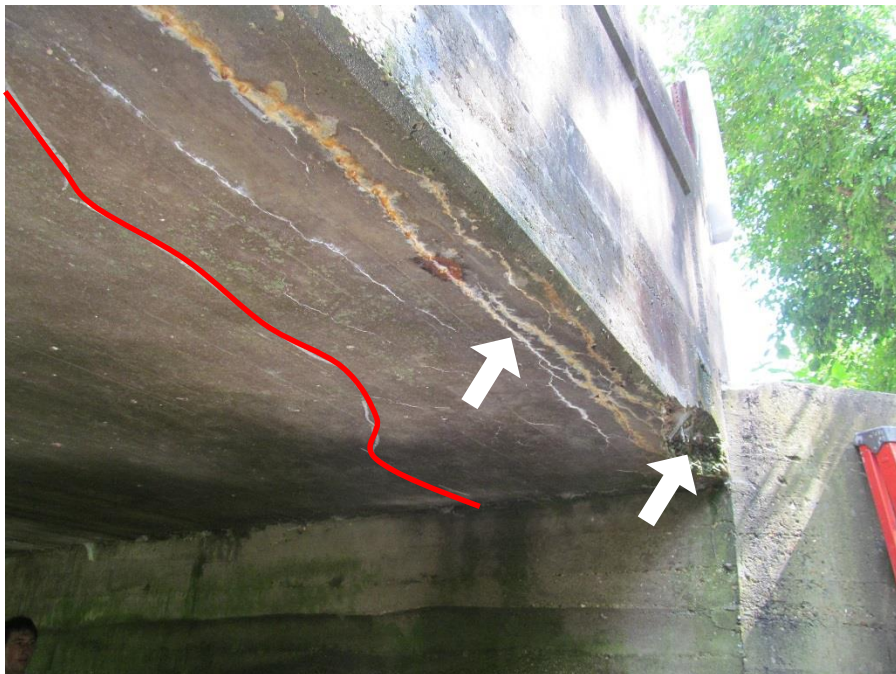
*Figure 4. Spalled concrete and efflorescence (arrows) at southwest corner of the deck soffit (red line shows extent of delaminated concrete).*

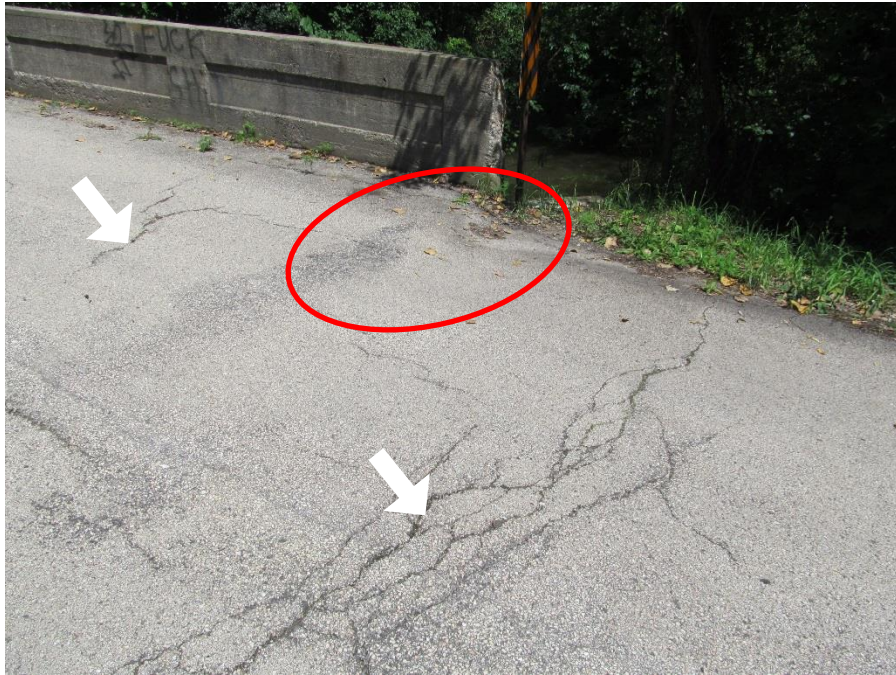
*Figure 5. Settlement of approach pavement at the southeast corner of the bridge deck (arrow) and transverse cracking of the asphalt pavement (arrows).*

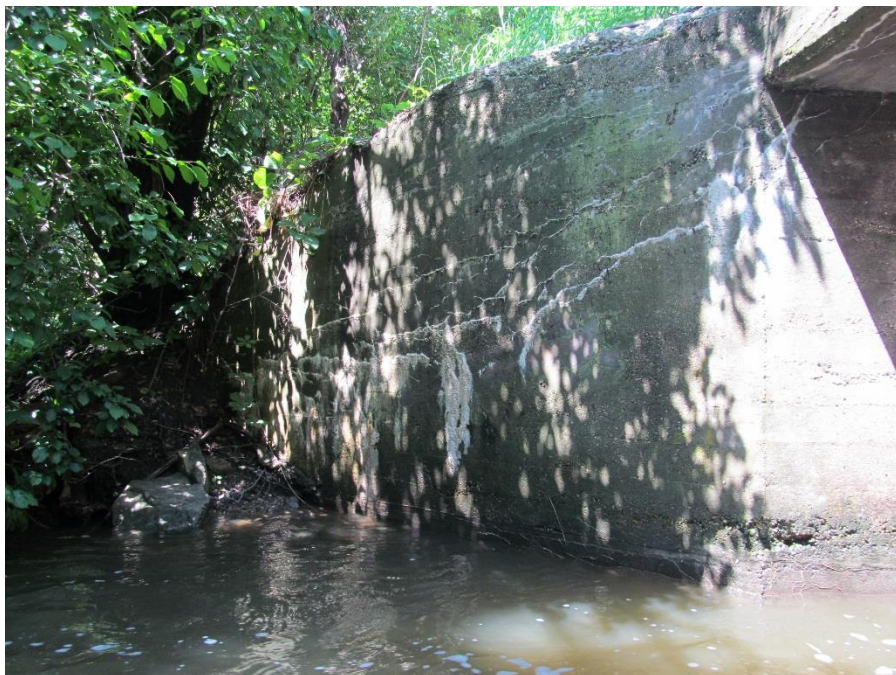
*Figure 6. Freeze/thaw damage on the northwest wingwall, including cracking with efflorescence.*

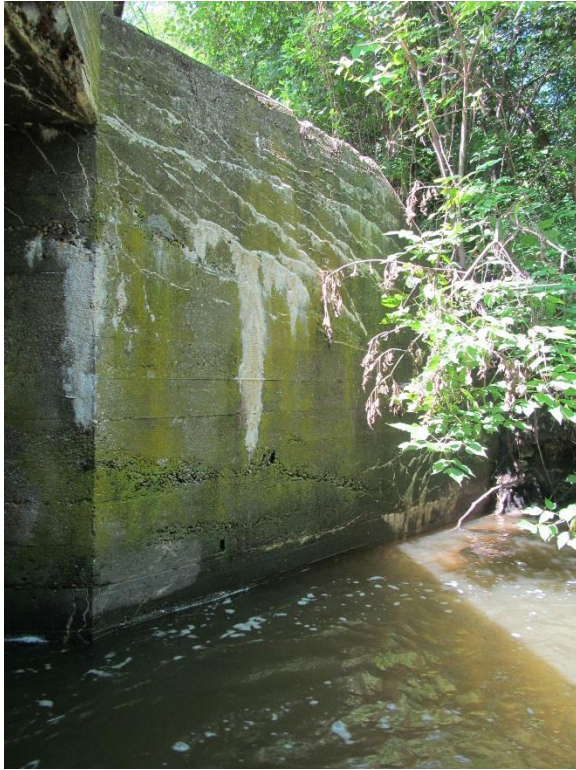
*Figure 7. Freeze/thaw damage at the top of the northeast wingwall highlighted by cracking with efflorescence.*

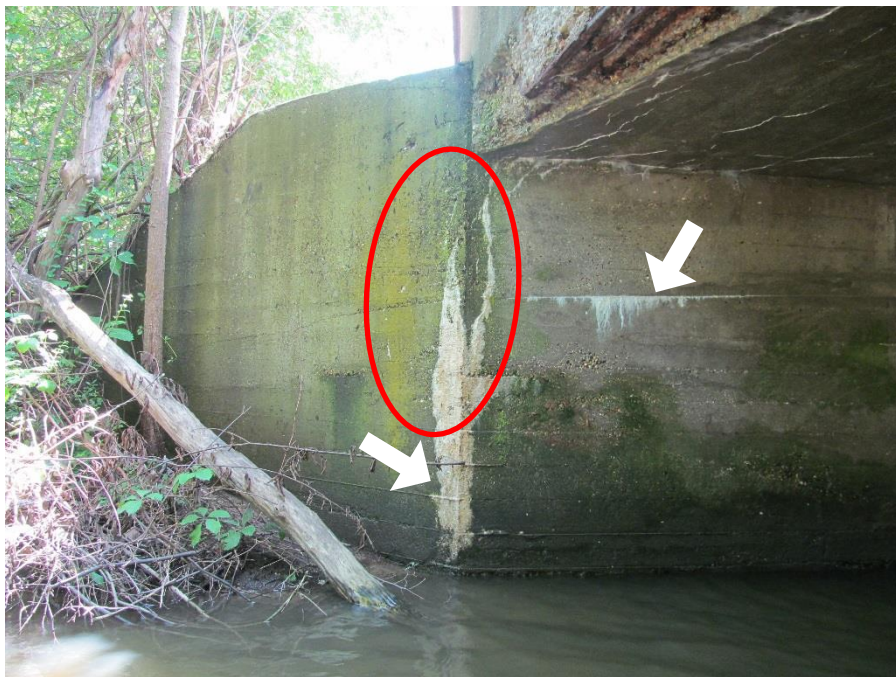
*Figure 8. South abutment showing areas of efflorescence (arrows) and delamination (circle).*

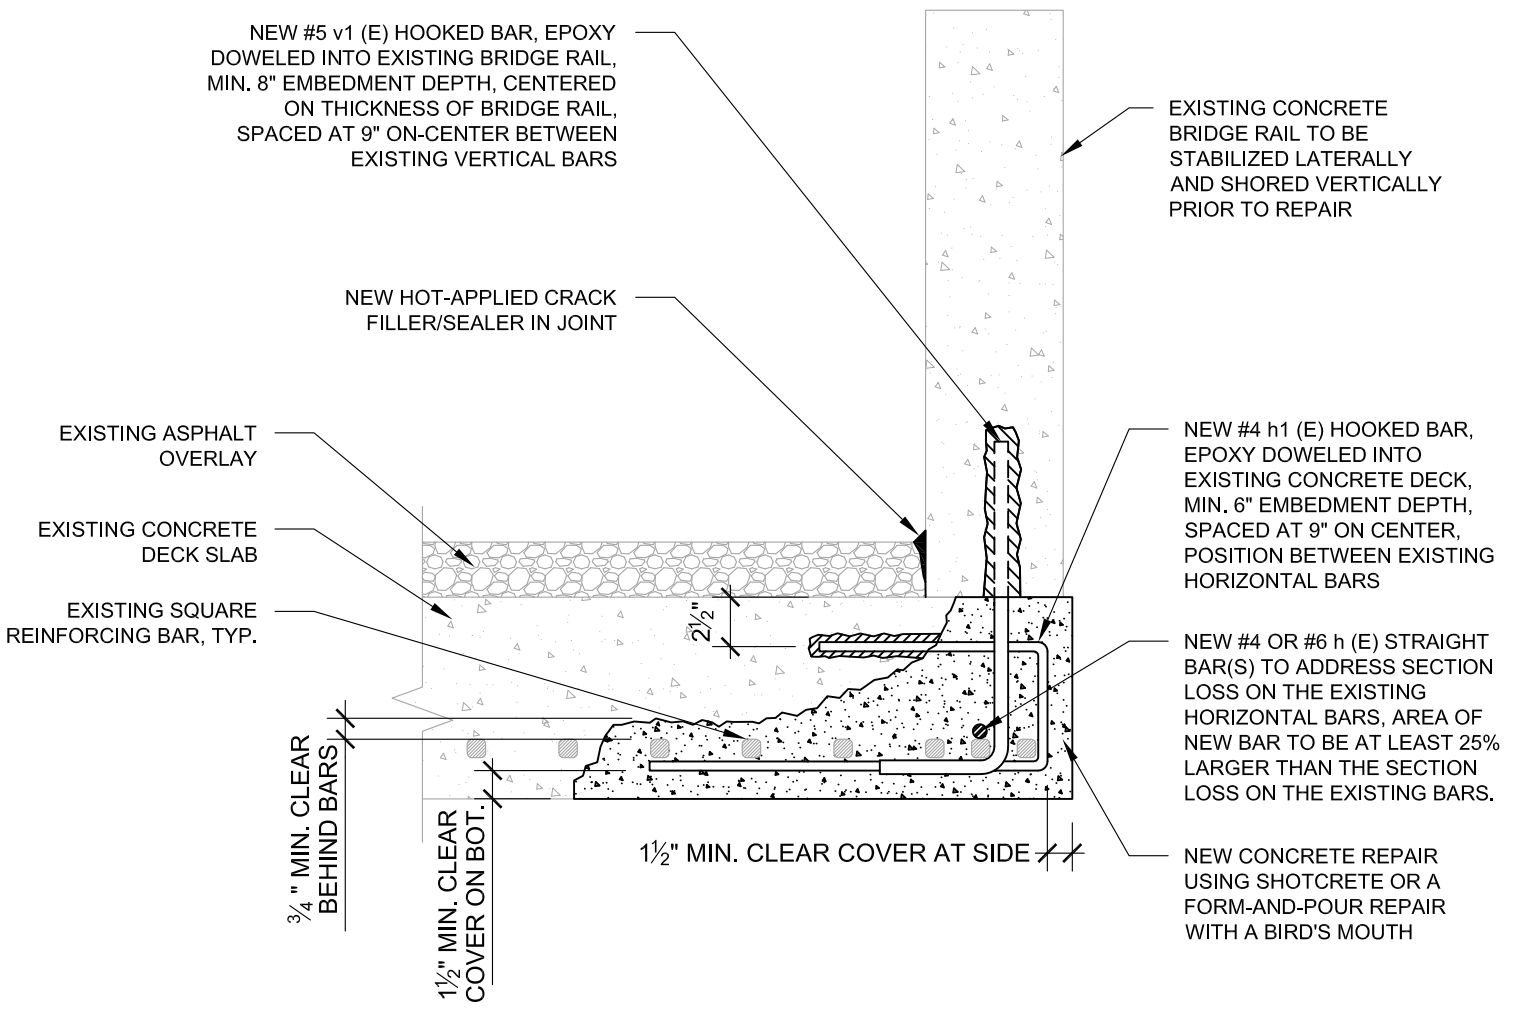
**A-1** SECTION THROUGH SLAB EDGE  
SCALE: 1" = 1'-0"

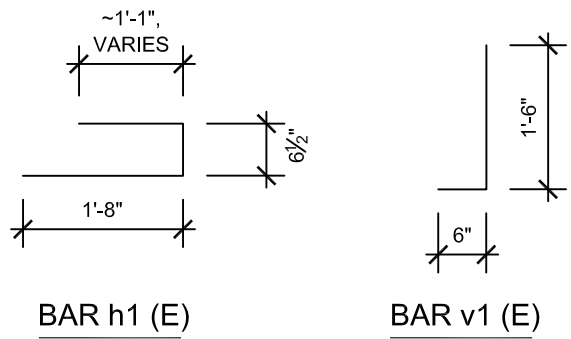
\*\*\* INDICATES THAT THE EXACT DIMENSIONS ARE UNKNOWN UNTIL THE CONCRETE DETERIORATION IS REMOVED AND THE REPAIR PROFILE IS DETERMINED. APPROXIMATE DIMENSIONS AND QUANTITIES SHOWN.
