Board of Health
AGENDA & NOTICE OF MEETING

Re: Ridge Road Depressional Area
Board of Health Meeting Follow-up

Re: Geotechnical Investigation
337/339 Ridge Road
Barrington Hills, Illinois

**WATER QUALITY REPORT
October 2017**

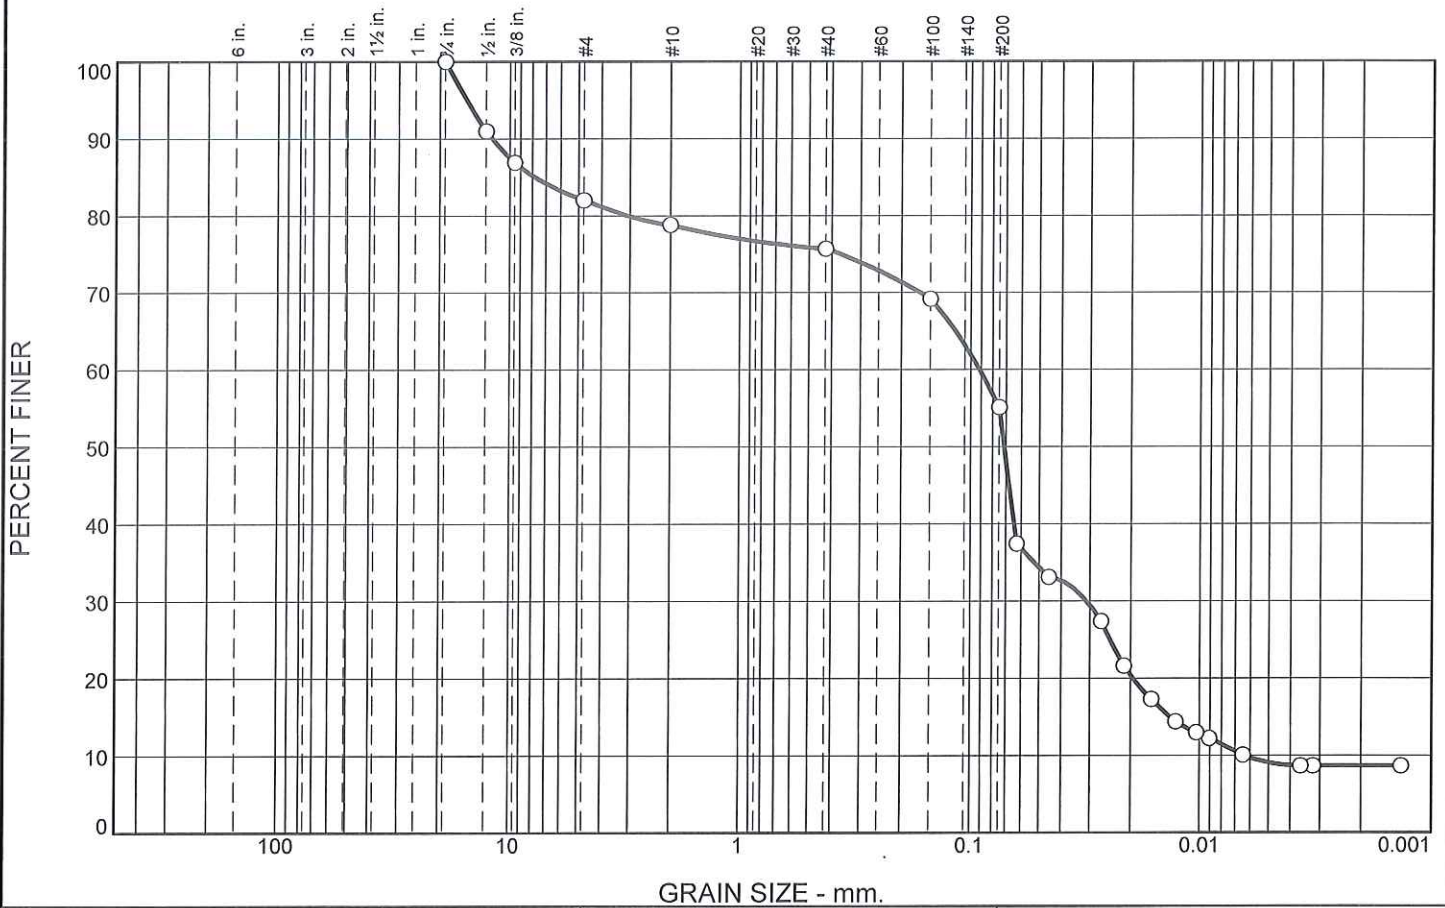
Particle Size Distribution Report

% +3"	% Gravel		% Sand			% Fines	
	Coarse	Fine	Coarse	Medium	Fine	Silt	Clay
0.0	0.0	18.0	3.2	3.1	20.6	46.5	8.6

SIEVE SIZE	PERCENT FINER	SPEC.* PERCENT	PASS? (X=NO)
3/4	100.0		
1/2	91.0		
3/8	86.9		
#4	82.0		
#10	78.8		
#40	75.7		
#100	69.2		
#200	55.1

Silty Loam

D₉₀= 11.9813 D₈₅= 7.8065 D₆₀= 0.0917
D₅₀= 0.0714 D₃₀= 0.0311 D₁₅= 0.0135
D₁₀= 0.0064 C_u= 14.40 C_c= 1.66

Location: Boring 1
Sample Number: 4

Depth: 6.5' - 7.5'

It is our understanding that drywells or other means are being considered to assist in surface drainage on this property. Grain-size analysis testing was performed on selected samples to determine USDA soil classifications. The soils encountered above the sand/gravel mixtures present at the bottom of borings B-1 and B-3 consisted of Silty Loam and Silty Clay soils. The Silty Loam and Silty Clay soils have low design infiltration rates of approximately 0.13 in./hr. and 0.07 in./hr. respectively due to the high percentages of clay and silt.

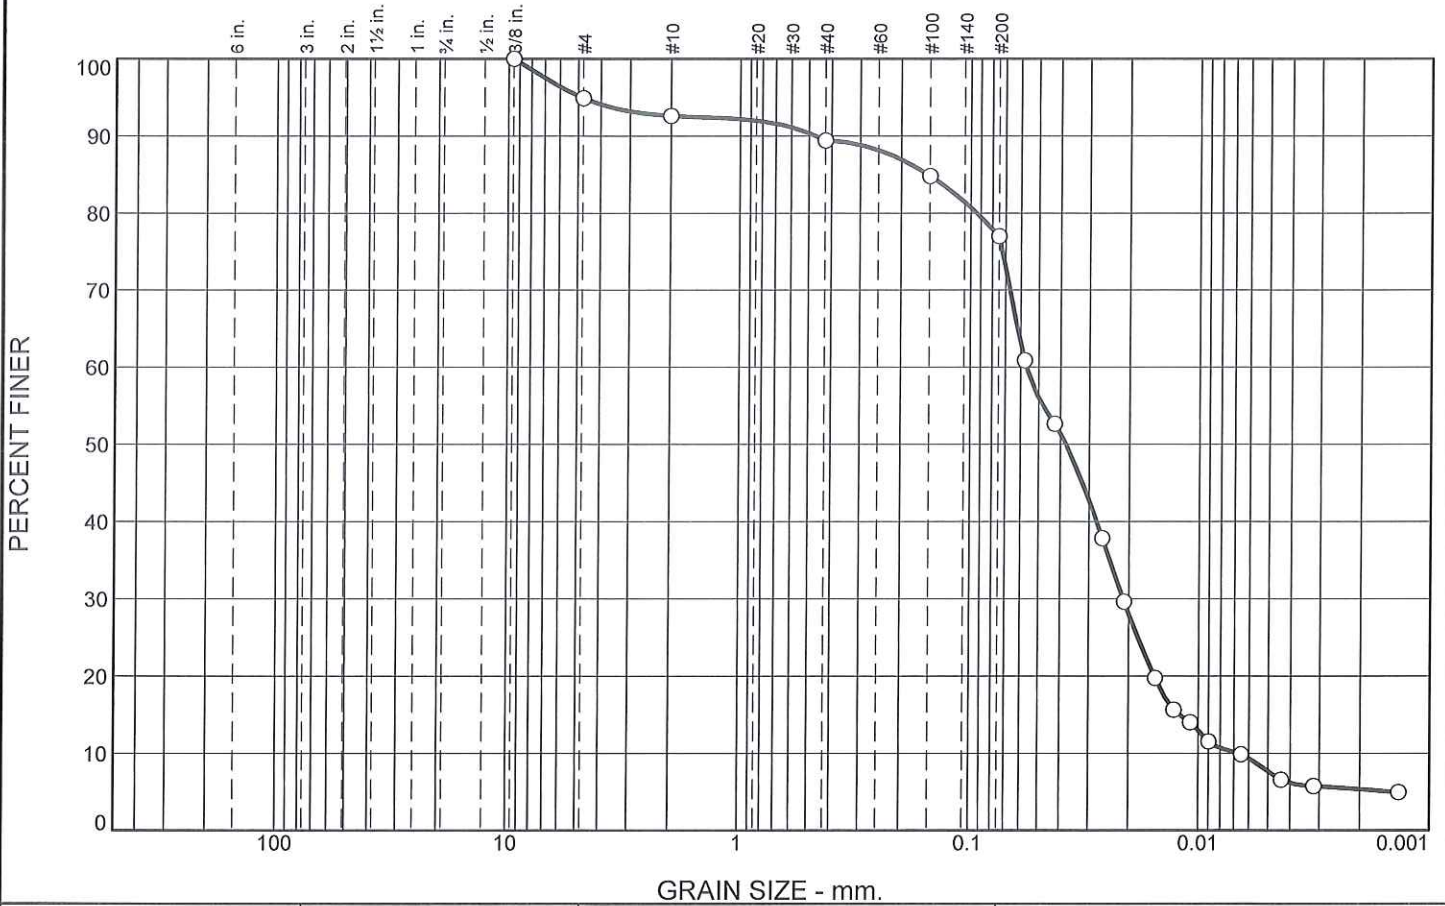
Particle Size Distribution Report

% +3"	% Gravel		% Sand			% Fines	
	Coarse	Fine	Coarse	Medium	Fine	Silt	Clay
0.0	0.0	5.1	2.3	3.2	12.4	71.6	5.4

SIEVE SIZE	PERCENT FINER	SPEC.* PERCENT	PASS? (X=NO)
3/8	100.0		
#4	94.9		
#10	92.6		
#40	89.4		
#100	84.8		
#200	77.0

Silty Loam

Coefficients
 D₉₀= 0.4700 D₈₅= 0.1536 D₆₀= 0.0564
 D₅₀= 0.0379 D₃₀= 0.0212 D₁₅= 0.0121
 D₁₀= 0.0067 C_u= 8.47 C_c= 1.19

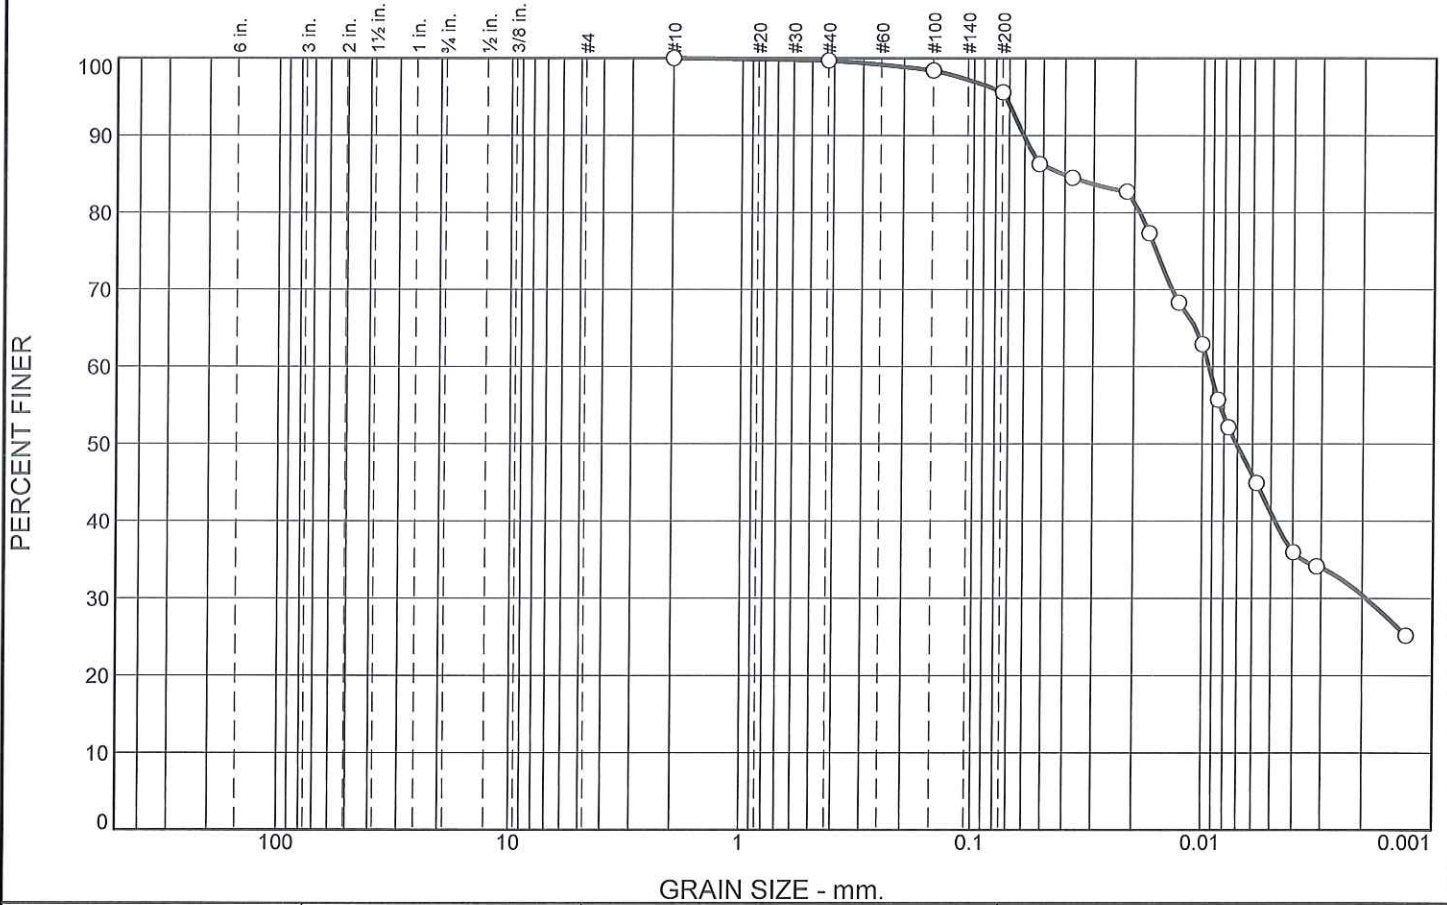
Particle Size Distribution Report

% +3"	% Gravel		% Sand			% Fines	
	Coarse	Fine	Coarse	Medium	Fine	Silt	Clay
0.0	0.0	0.0	0.0	0.3	4.1	65.2	30.4

SIEVE SIZE	PERCENT FINER	SPEC.* PERCENT	PASS? (X=NO)
#10	100.0		
#40	99.7		
#100	98.4		
#200	95.6

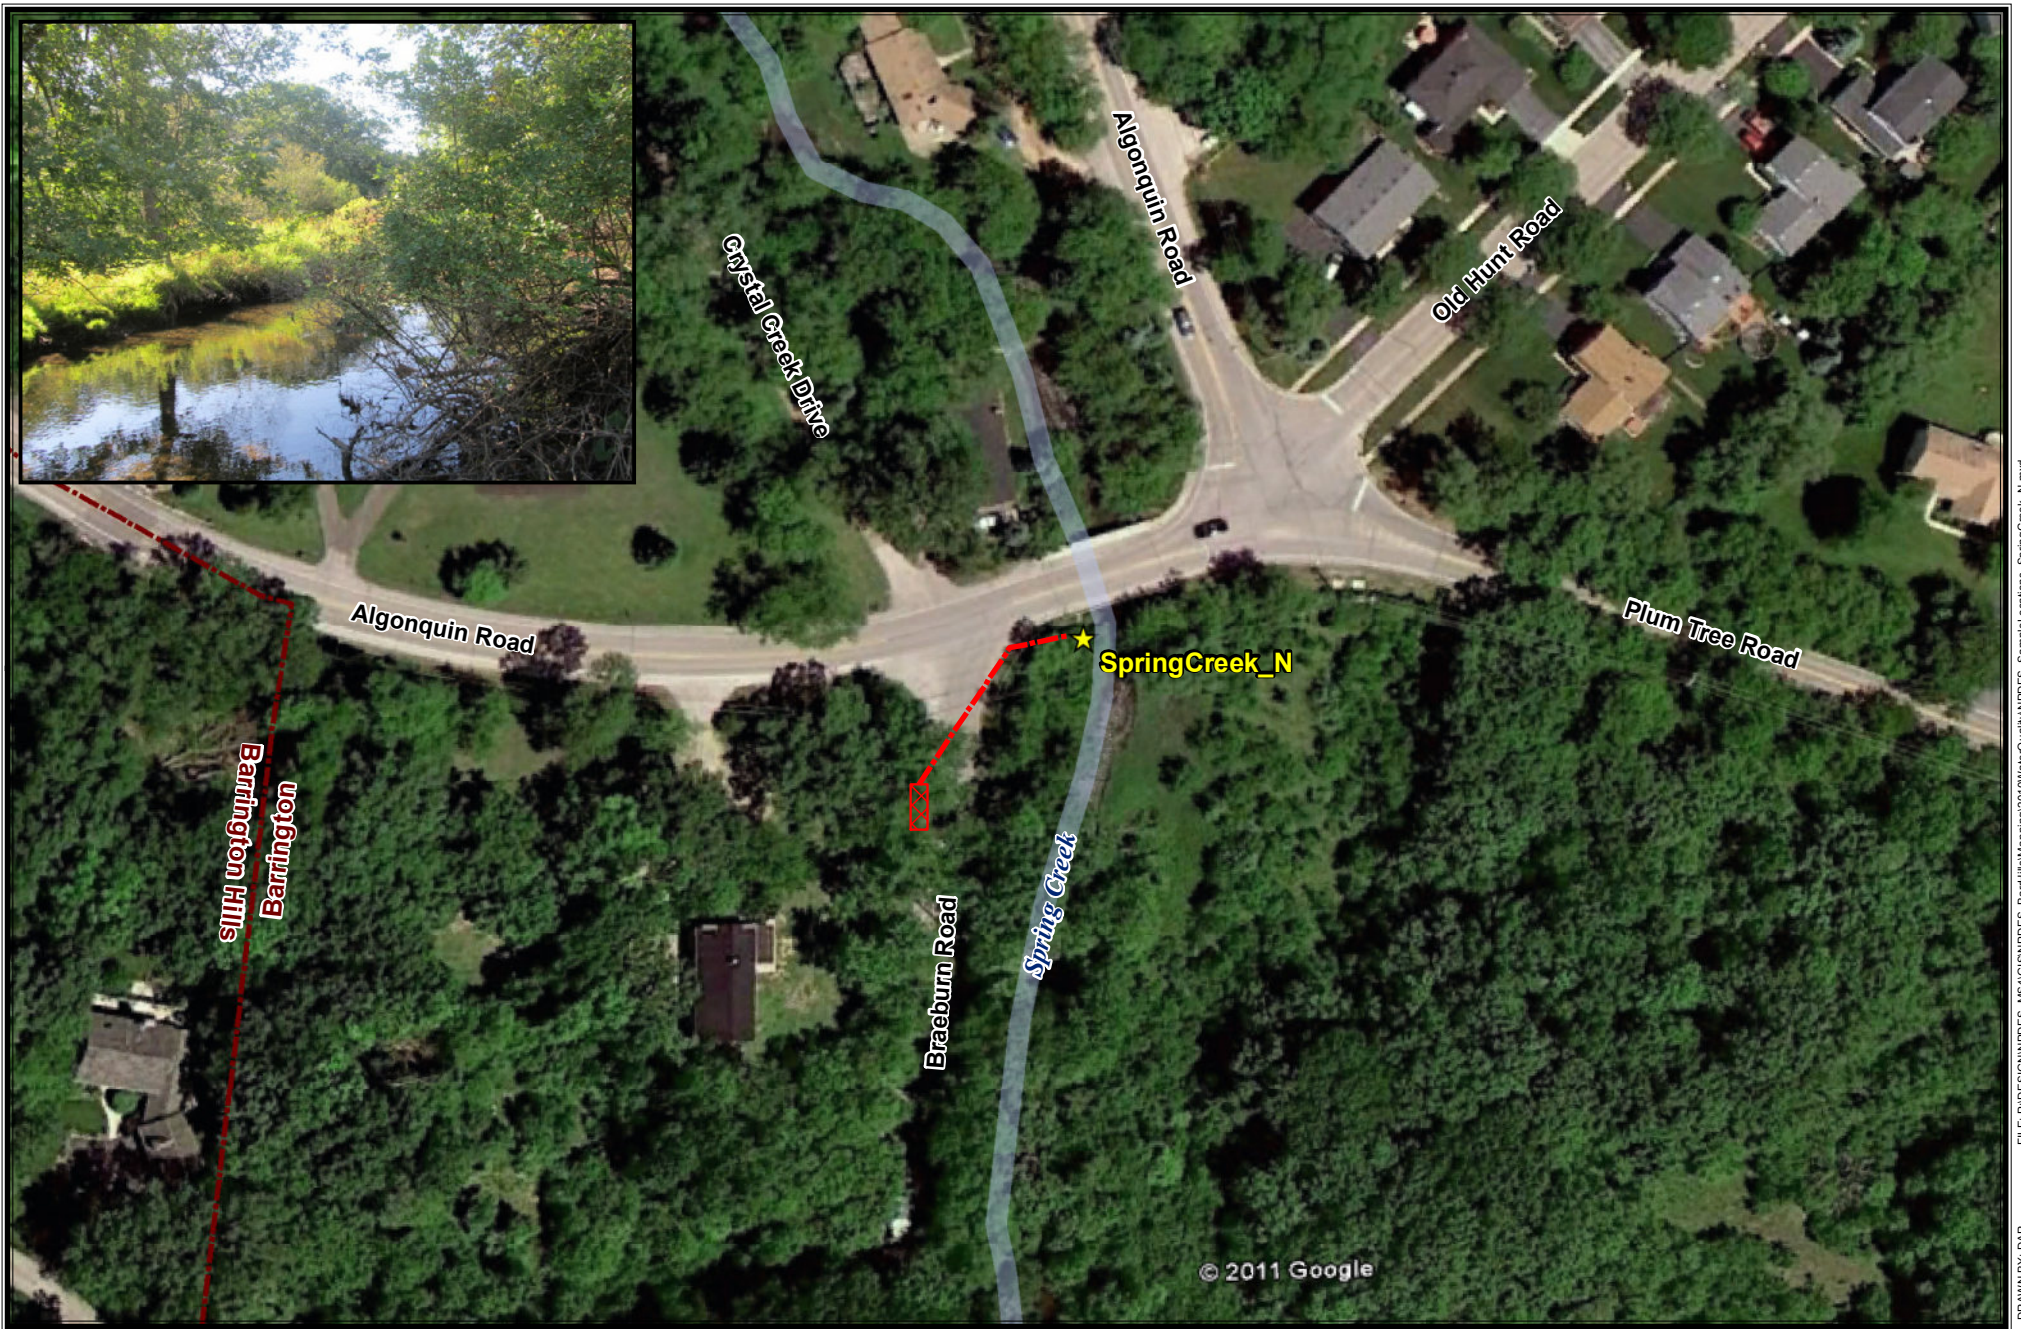
**GEWALT HAMILTON
ASSOCIATES, INC.**
Project: 9355.090
Map Code: 21038x11
DATE: 5/31/2011

Sources: BAGIS, Google Earth Imagery Date: 05/27/2010

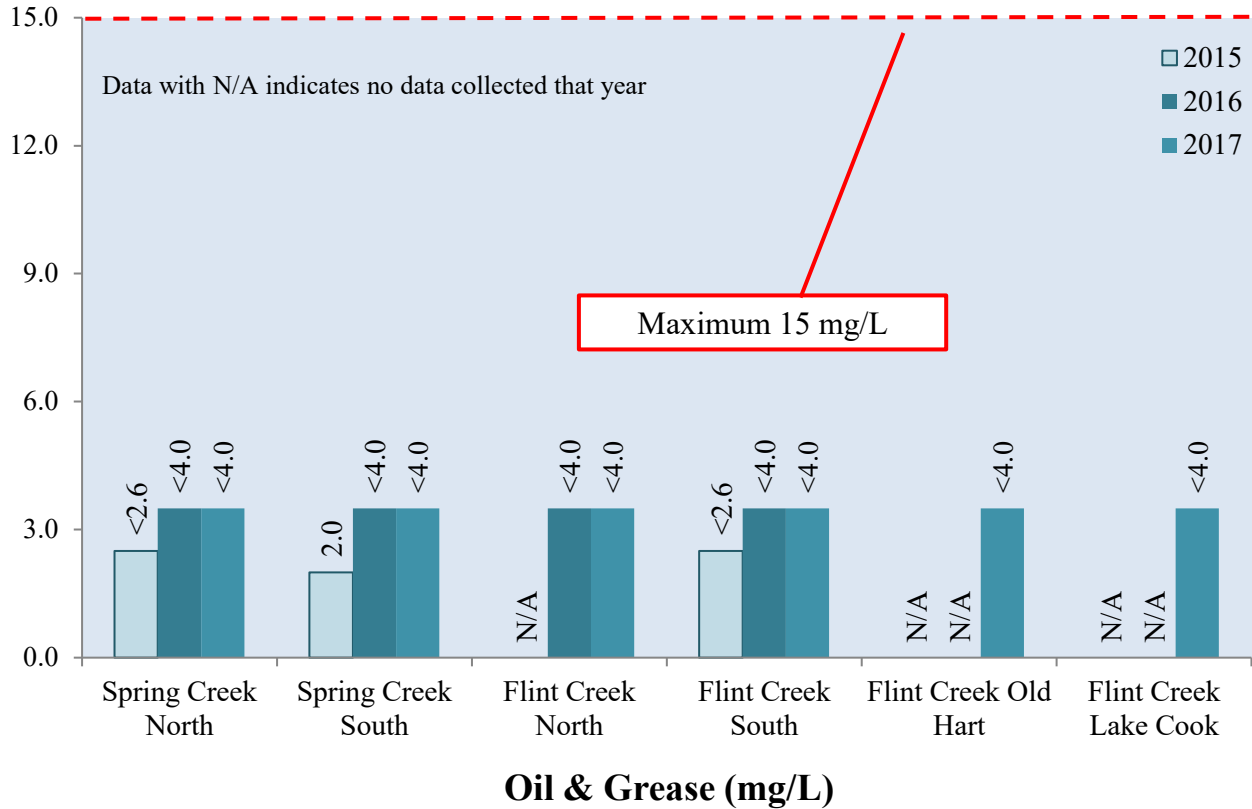
Graphs for each parameter are included on the following pages, which compare results from year to year.
