Plan Commission
AGENDA & NOTICE OF MEETING

PRELIMINARY ENGINEERING PLANS BATEMAN MEADOWS SITE IMPROVEMENT PLANS

WETLAND DELINEATION REPORT

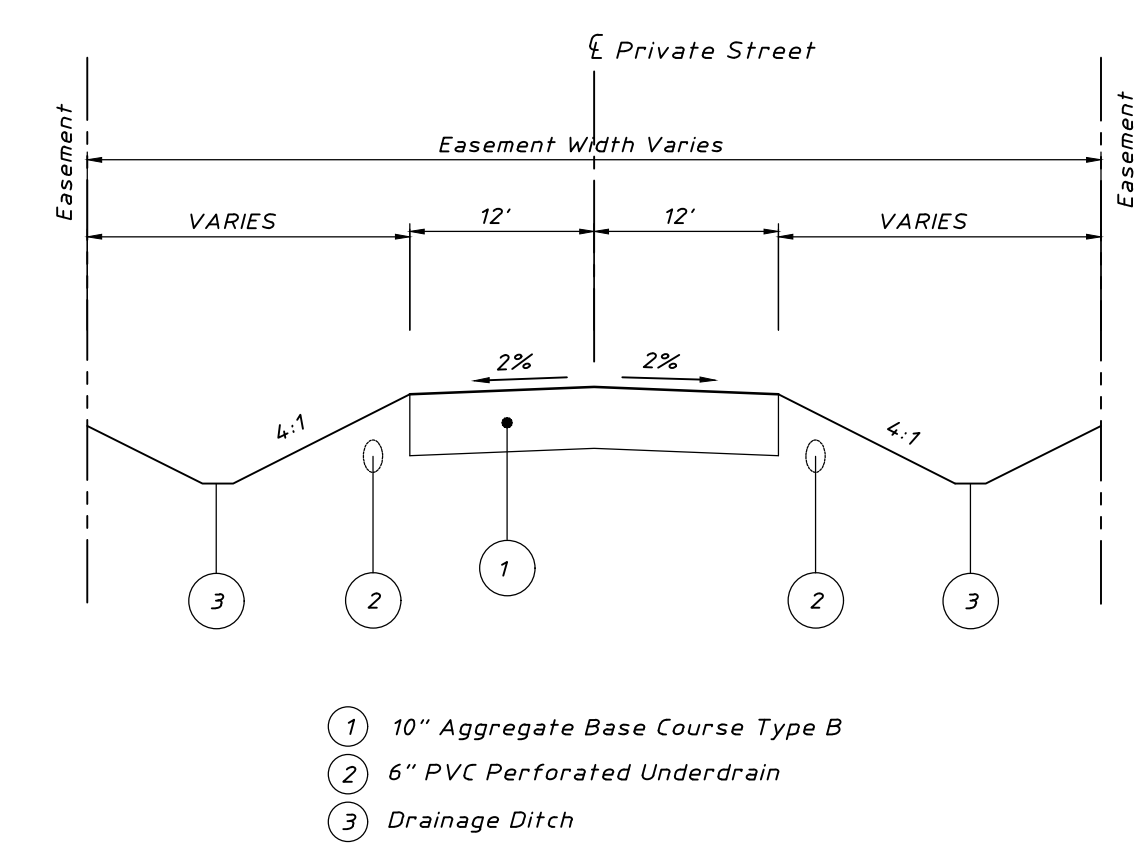
PRIVATE STREET CROSS-SECTION
NOT TO SCALE

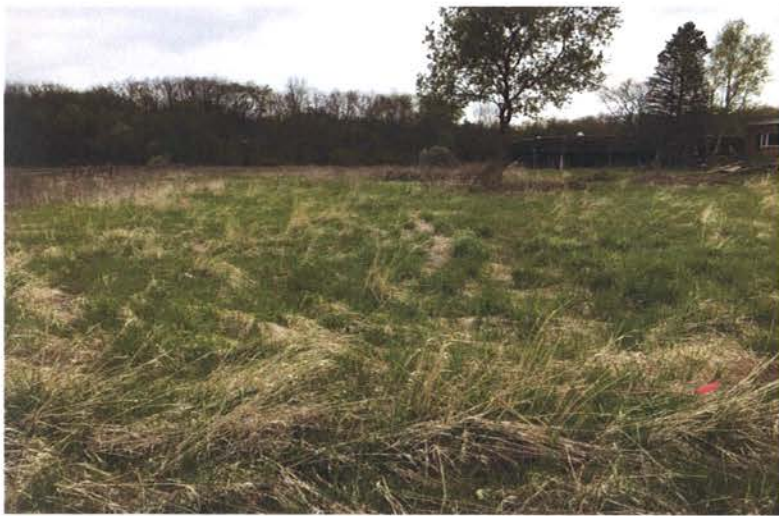
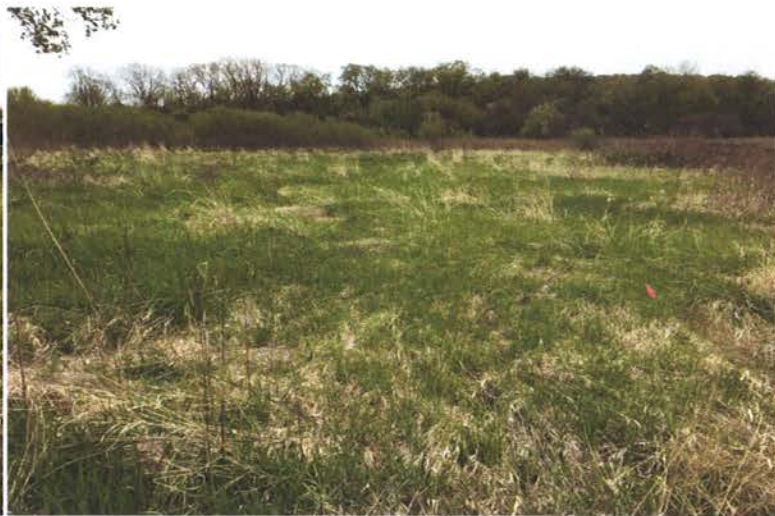
Wetland A is a depressional Reed Canary Grass wetland area. The wetland was historically separated from Wetland B due to the installation of a gravel driveway.

Wetland A: Wetland A is a depressional reed canary grass wetland that receives surface flow from adjacent areas. The wetland was historically part of the larger wetland to the south (wetland B) but was separated due to the construction of the gravel driveway. Wetland A is characterized by data point 1A and was determined to be **0.24 acres**. Wetland A is a depressional wetland that does not have a regulated outfall. A culvert or surface conveyance was not noted draining the wetland area. The dominant vegetation found was determined to be Reed Canary Grass (*Phalaris arundinacea*) and Sandbar Willow (*Salix interior*).

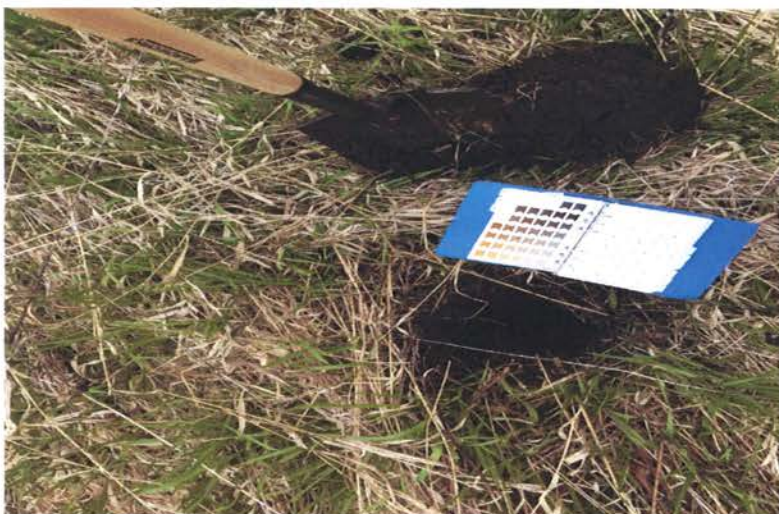
Data point 1A confirms a wetland soil condition.

During our investigation positive wetland hydrology is met with the primary indicators of Saturation (A3). Mapped soil is identified as Ashkum silty clay loam (232 A) which is a poorly drained soil. Primary soil indicators of thick dark surface (A12) was noted within the flagged boundary.

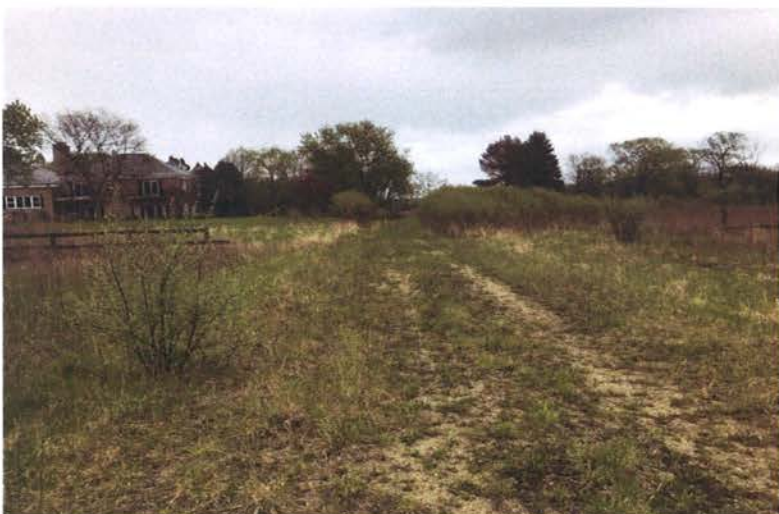
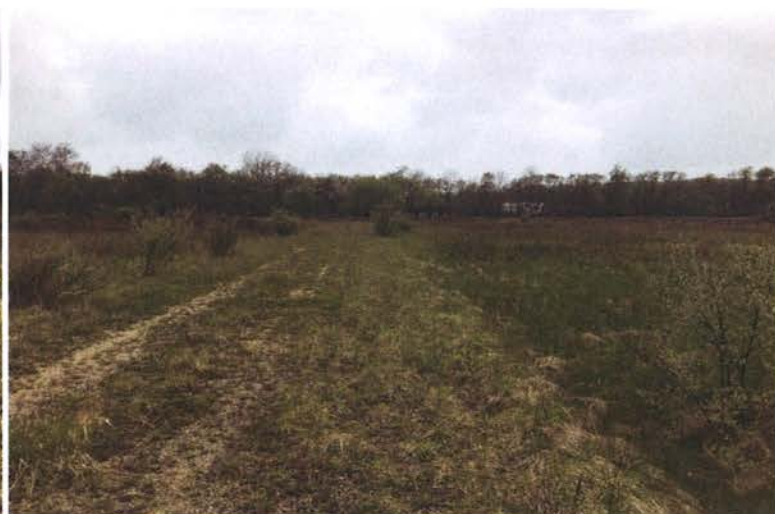
A gravel driveway is found within the property limits. The gravel driveway provides access to a abandon barn found on the west property line.

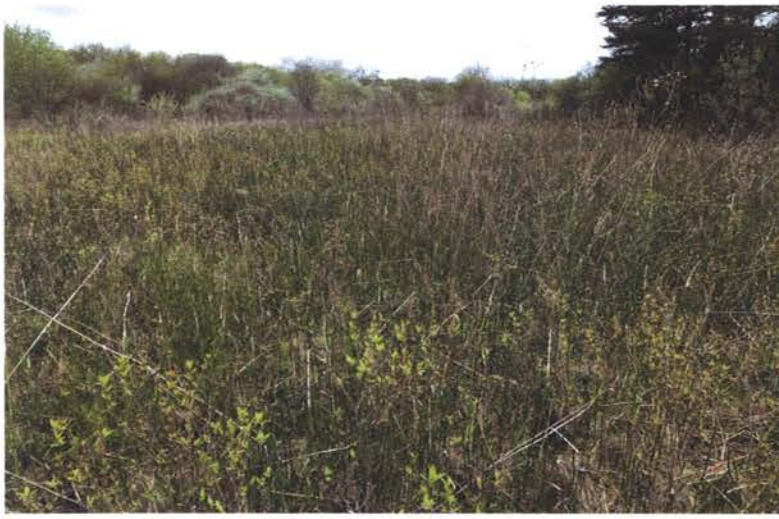
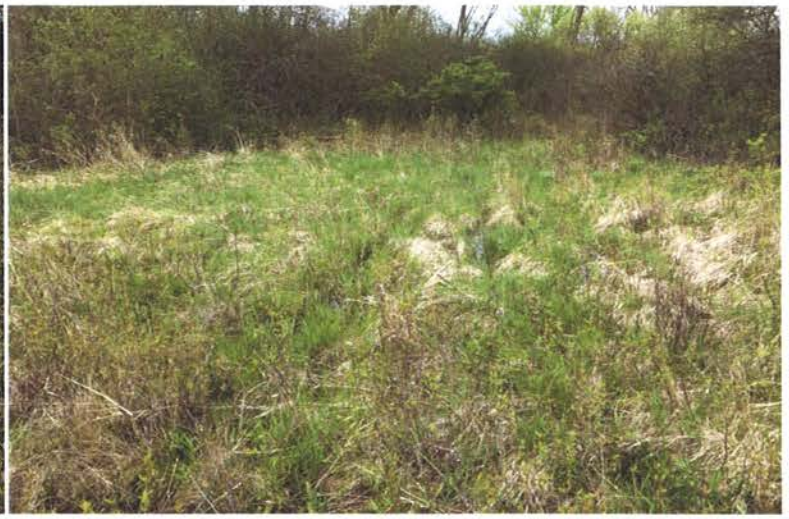
Wetland B consists of a wet meadow, wooded, marsh and open water wetland area.

Wetland B: Wetland B can be located on the south portion of the property, and extends off-site to the southwest and southeast. Wetland B is tributary to the Spring Creek ecosystem. The delineated boundary is characterized by data point **2B, 7B and 9B and** has been determined to be **11.67 acres** in size. The delineated wetland consists of wet meadow, degraded wet meadow, scrub/shrub, wooded, marsh and open water wetland area. The wetland is primarily hydrated by an off-site stream but areas of ground water upwelling was noted within property boundary. Wetland B exhibits moderate to high quality plant life.

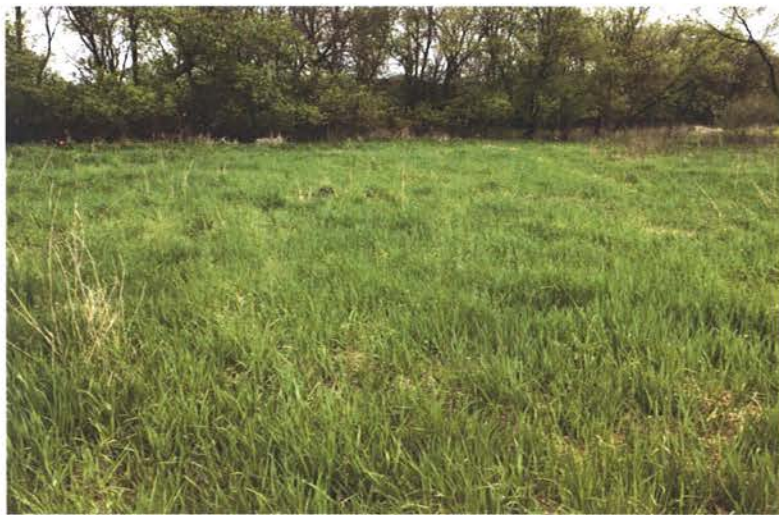
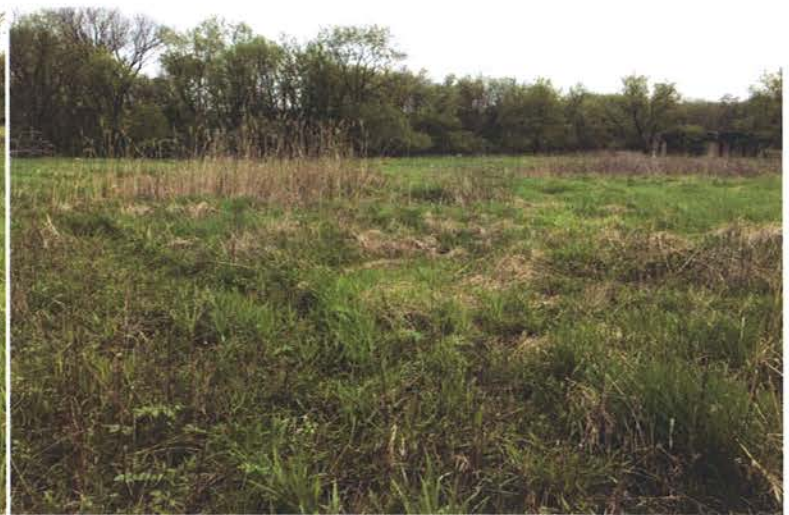
Drainage is conveyed into the wetland area from the upstream watershed and is conveyed to the South.

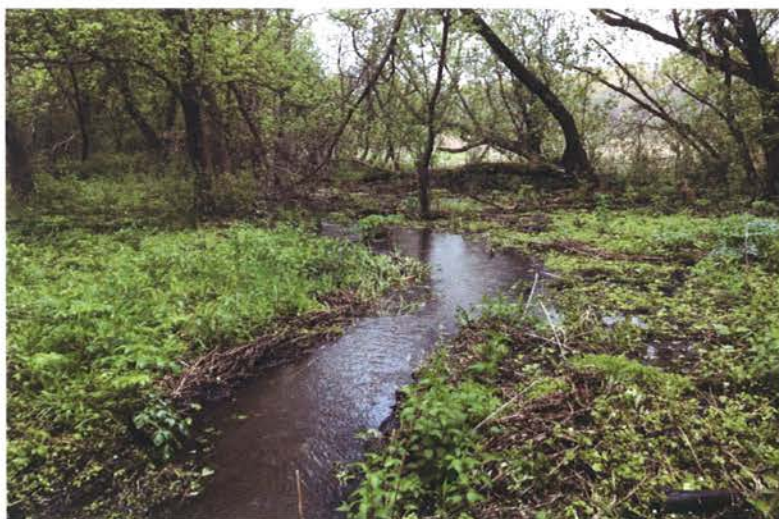
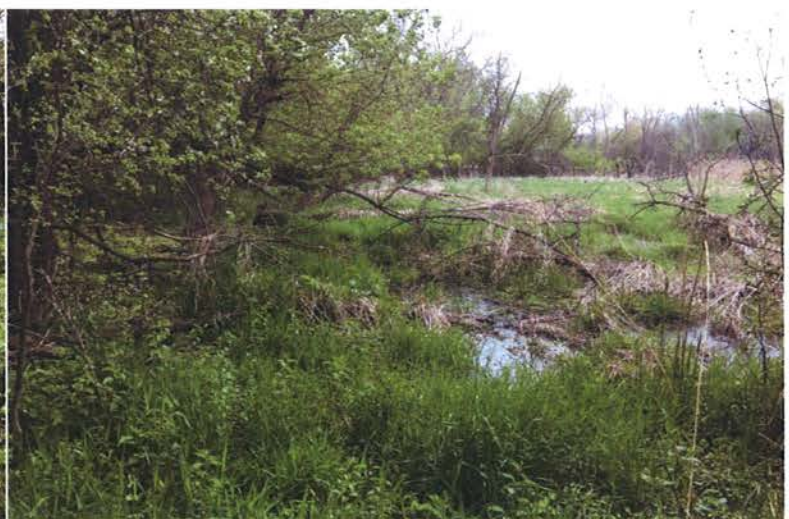
The main wetland complex is hydrologically connected to Spring Creek.

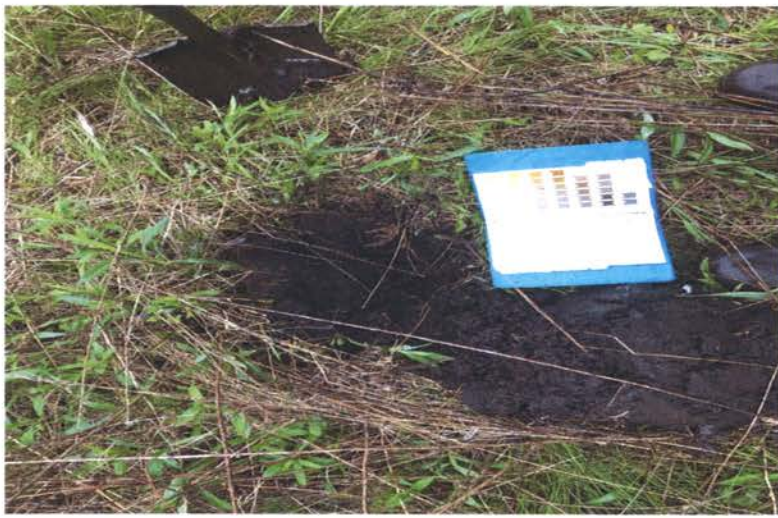
Data point 1B confirms an upland soil condition

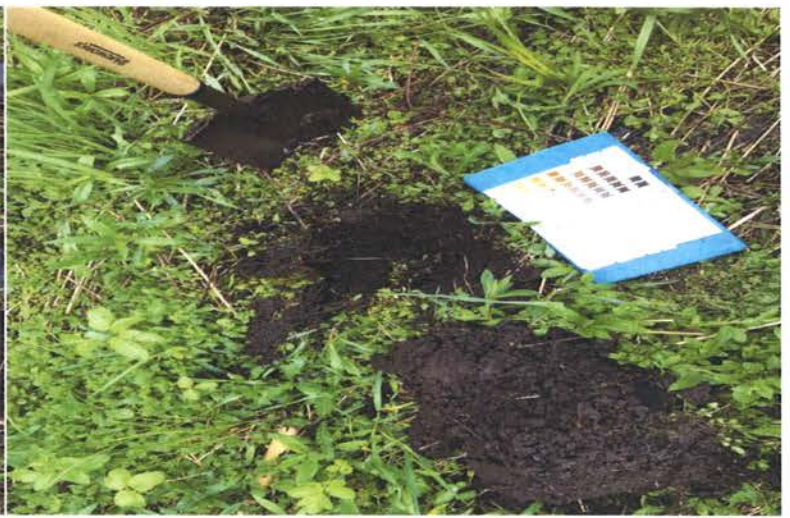
Data point 2B confirms a wetland soil condition

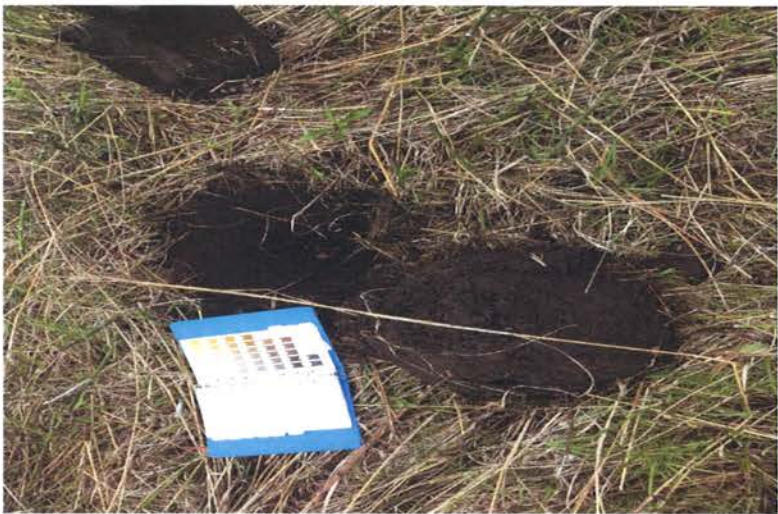
Data point 3B confirms a upland soil condition

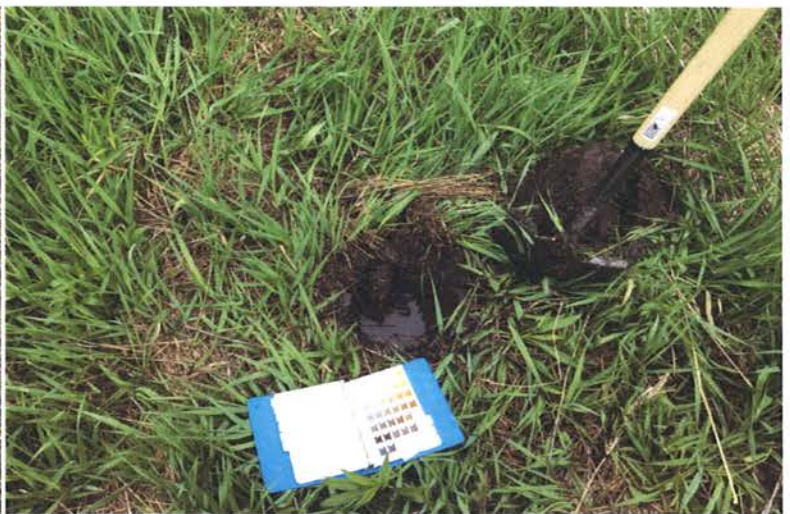
Data point 7B confirms a wetland soil condition

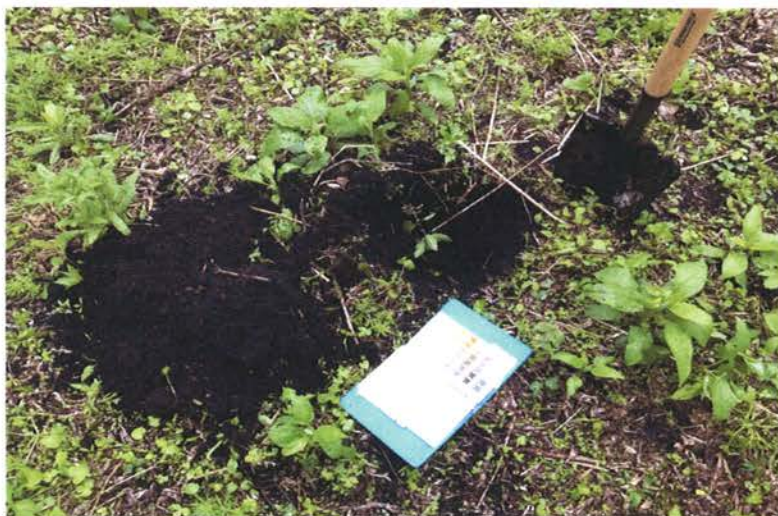
Data point 8B confirms a upland soil condition
