A RESOLUTION AUTHORIZING THE EXECUTION OF AN AGREEMENT WITH KINGS CONTRACTING, INC. FOR THE REPAIR OF THE ROOF OF VILLAGE PROPERTY AT 120 ALGONQUIN ROAD

To: Trustee Zubak
From: Robert Kosin
cc: Board of Trustees, Village President
Date: September 22, 2017
Re: Fire Station Roof Repair

**RE: Fire Station #2
Barrington Hills, IL**

PROJECT: Village of Barrington Hills Fire Station #2			JOB NO.: 14001
ROOF AREA: North Roof	ROOF AGE: 20 years	BLDG TYPE: Masonry	ROOF SLOPE: 5:12
EVALUATION BY: Robert Heideman and William Richardson on April 11, 2014

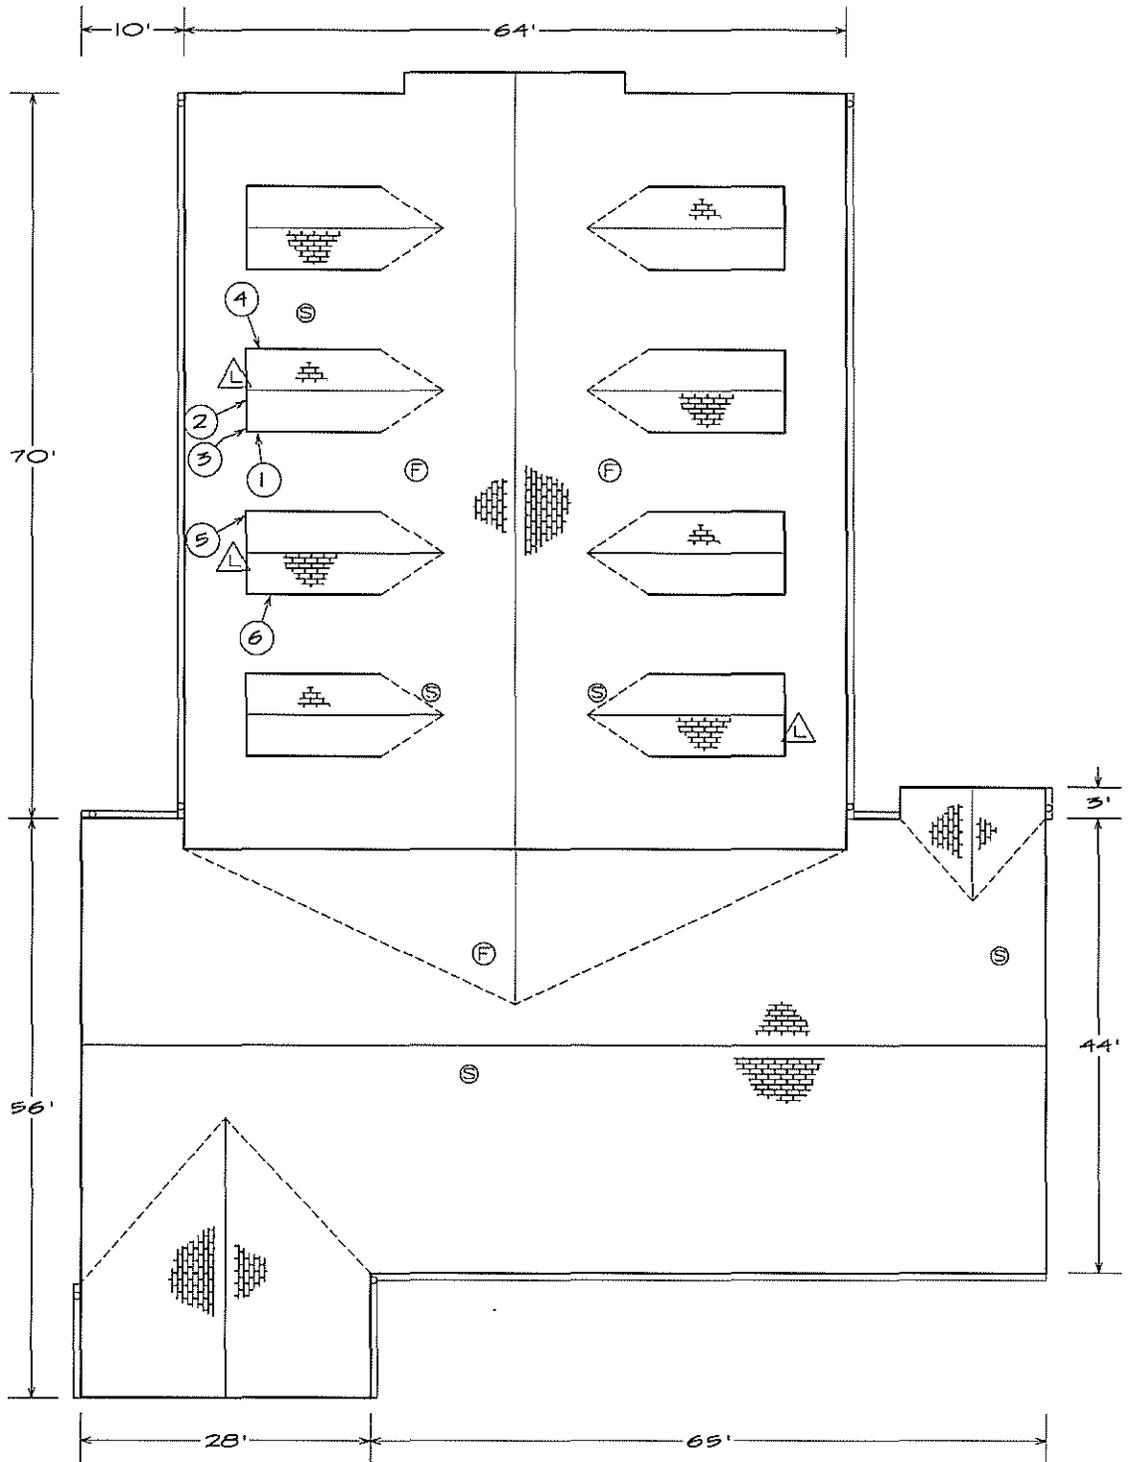
The leaks were reported to occur near the west end of the Apparatus Room. The two leak locations coincide with the location of the dormers that are visible from the outside of the building. Leaks were reported to have never appeared at these locations prior to the storm. It is not known if these leaks have occurred since the original storm.

During the investigation of the roofing in the leak areas, no significant defects were found. The investigation moved to the windows and siding on the dormer. The windows were properly sealed and showed no defects. The siding was detailed correctly with one exception. When investigating the flashings and terminations, there was no felt or polyethylene underlayment visible. This underlayment serves multiple purposes, one of them being waterproofing. Siding is water shedding, not waterproof and extreme conditions can allow moisture to migrate behind the siding. Underlayment can be looked at as a final line of defense should moisture penetrate behind the siding. It is my opinion that the extreme weather conditions during this storm created a situation where water was blown behind the siding and ran down the unprotected walls, where it eventually entered into the building.

should a breach occur. Our recommendation is to remove the siding currently in place on the dormers to allow for the installation of an underlayment membrane. Since the siding will likely incur damage during removal, new siding should be installed. Installing the underlayment will prevent moisture that gets behind the siding during extreme weather from entering the building.
